Sustainable Fruition of Cultural Heritage in Areas Affected by Rockfalls

Simone Mineo

and Giovanna Pappalardo *

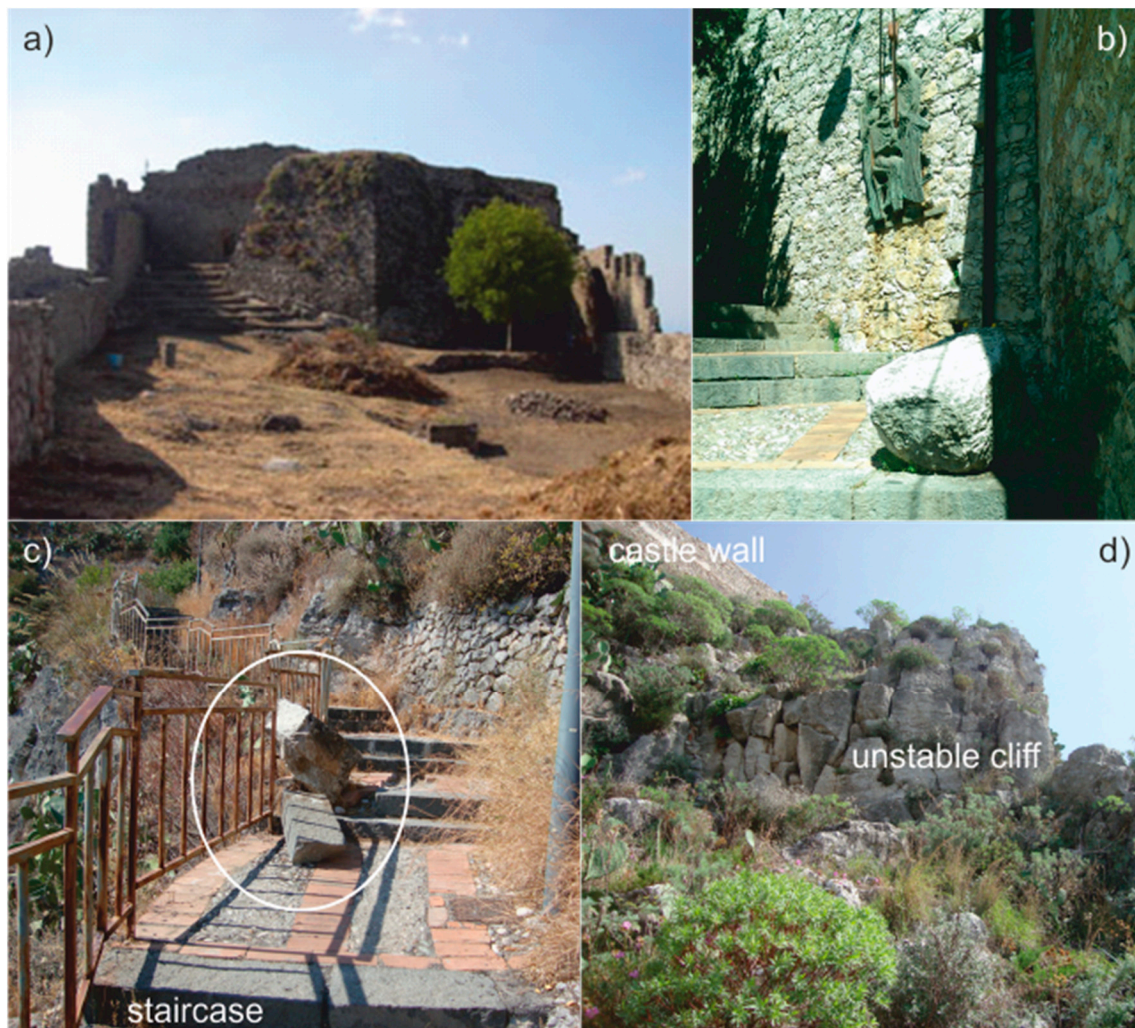
The Saracen Castle stands on the top of Monte Tauro, a 390 m-high carbonate cliff, where the remains of this fortification are represented by the imposing tower, the walls, a cistern and an underground corridor (Figure 3a). Today, the castle is closed to the public, although tens of tourists daily reach the top of Monte Tauro to see the wonder of this ancient historic monument and the magnificent panorama from the summit. To reach the monument, a pedestrian path (PPW) starts from the lower city center of Taormina and climbs steep rock slopes through a series of staircases with twelve stops at the Stations of the Cross, making this pathway relevant even from the religious point of view (Figure 3b). This infrastructure shows widespread damage, both in the pavement and at some segments of the banister, brought by falling rock boulders detached from the upper carbonate cliff. Some of these blocks, with a volume of about 0.15 m³ can still be found either on the pathway or at its

side (Figure 3b,c), and signs of recent detachments can be seen at the sub-vertical rock face, along with evidence of unstable blocks (Figure 3d).

Figure 3. (a) Internal view of the castle; (b) block stopped at a Station of the Cross; (c) block stopped by the banister and damaging the road pavement; (d) loose rock mass.

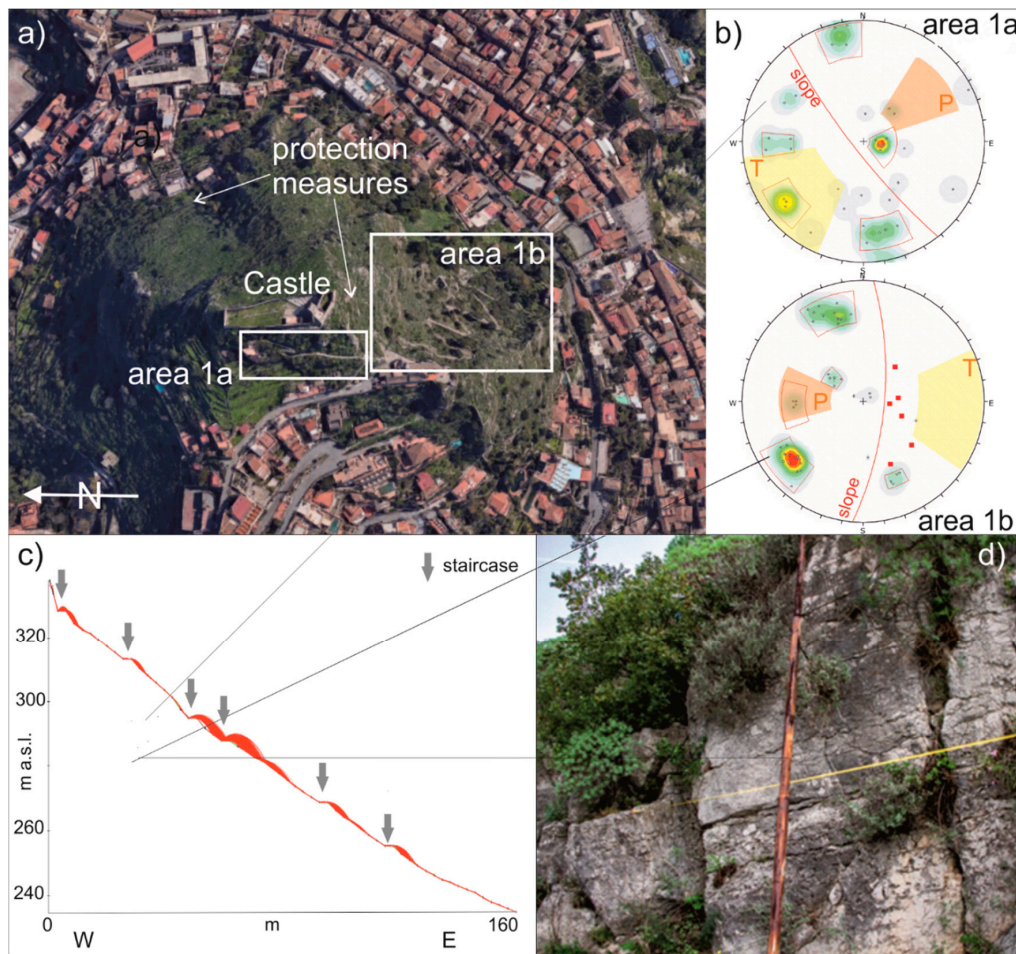
Sector 1a: Enclosing the highest portion of PPW, in the proximity of the entrance of the castle, where remedial measures have never been performed and where loose rocks were surveyed (Figure 4a)

Sector 1b: Enclosing the downstream portion of PPW, which is still affected by boulders detaching from the northwestern cliff (Figure 4a)

The geostructural setting of the rock mass was studied by Mineo et al. [35], who performed rock mass surveys highlighting that the most frequent unstable kinematic pattern is the planar sliding, followed by toppling and some wedge configurations (Figure 4b). The geomechanical quality of the rock, assessed by the Rock Mass Rating system (RMR, [47]) was assessed as “fair rock” (RMR between 41 and 60), and some simulated trajectory of blocks underline that PPW is affected by block bounces at several spots (Figure 4c).

Figure 4. (a) Satellite map of the area 1; (b) representative stereonets of the sub-areas (data from [35], P-critical area for planar sliding, T-critical area for toppling, red squares are the intersection lines of unstable wedges); (c) representative rockfall simulation (modified from [35]); (d) apertures >100 mm at area 1a.

The final rating assigns the score of 52.7 and 48.65 for areas 1a and 1b, respectively. According to the RRRS classification system, both areas fall within class III (medium risk), where light measures (such as bolts, nets, removal of unstable blocks, simple light fences) are suggested. The difference between the two scores is due to the presence of a denser vegetation at area 1b, which plays a breaking action on falling boulders, the greater apertures of discontinuities at area 1a, and the absence of mitigation measures at area 1a. In this latter case, although at area 1b the highest portion of the southern cliff was secured by active measures, the eastern cliff (source area of the latest rockfalls) is still unprotected.

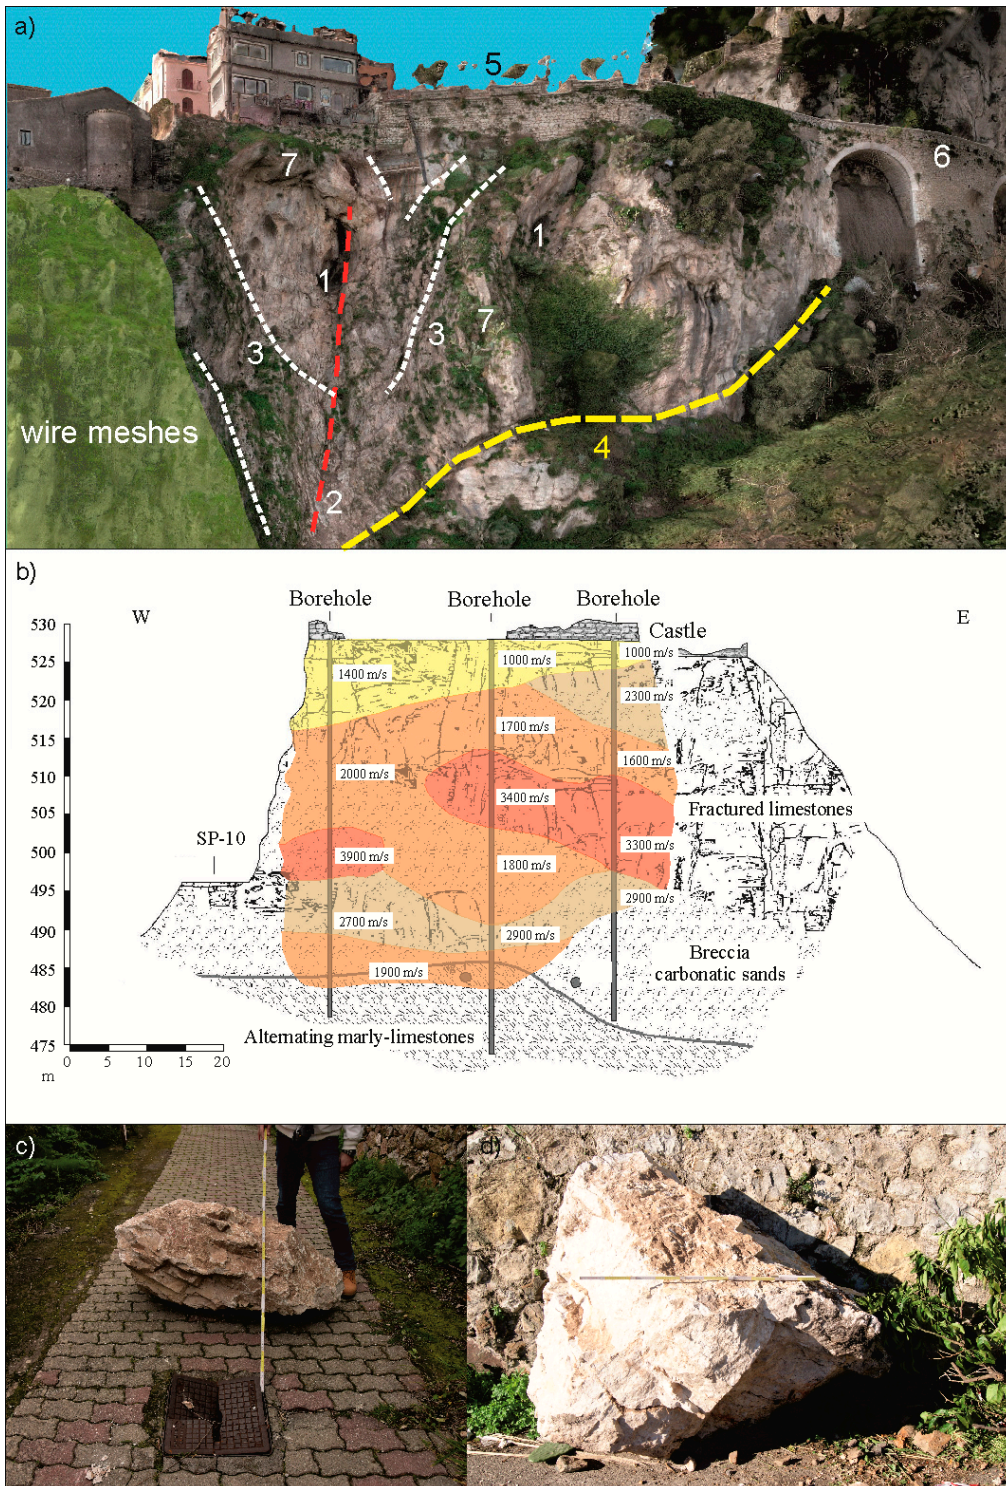
Although some remediation works were performed in the latest years, the northeastern portion of the cliff, below the city square, is still unsecured and shows critical signs of instability. All the latest events arise from this rock mass, with volumes up to 5 m^3 . The latest remarkable event occurred in 2019, when blocks reached a downstream bus stop and the SP-10 access road, leading to its temporary closure (Figure 5c,d). After this event, urgent remedial works were performed to build a further barrier to protect the road.

Figure 5. (a) 3D model of the cliff, with the following key features highlighted: 1: karst caves, 2: fault, 3: main discontinuities intersecting to form wedges, 4: shear plane, 5: MS, 6: SP-10, 7: greatest unstable volumes; (b) cross section of the Castelmola cliff reconstructed by means of borehole drillings and down-hole seismic surveys (modified after [39]); (c) block stopped at the pedestrian path in 2019 damaging its pavement; (d) block stopped at SP-10 in 2019.

The final rating allows classifying this as a high-risk area, with a 64.8 final score (Table 4), where the combination of active and passive protection measures is suggested. Here, the presence of wide karst caves in an unprotected cliff makes this spot a relevant threat for the fruition of the site, both at MS, where retreat phenomena could lead to the square collapse, and at the access routes (both pedestrian and SP-10).

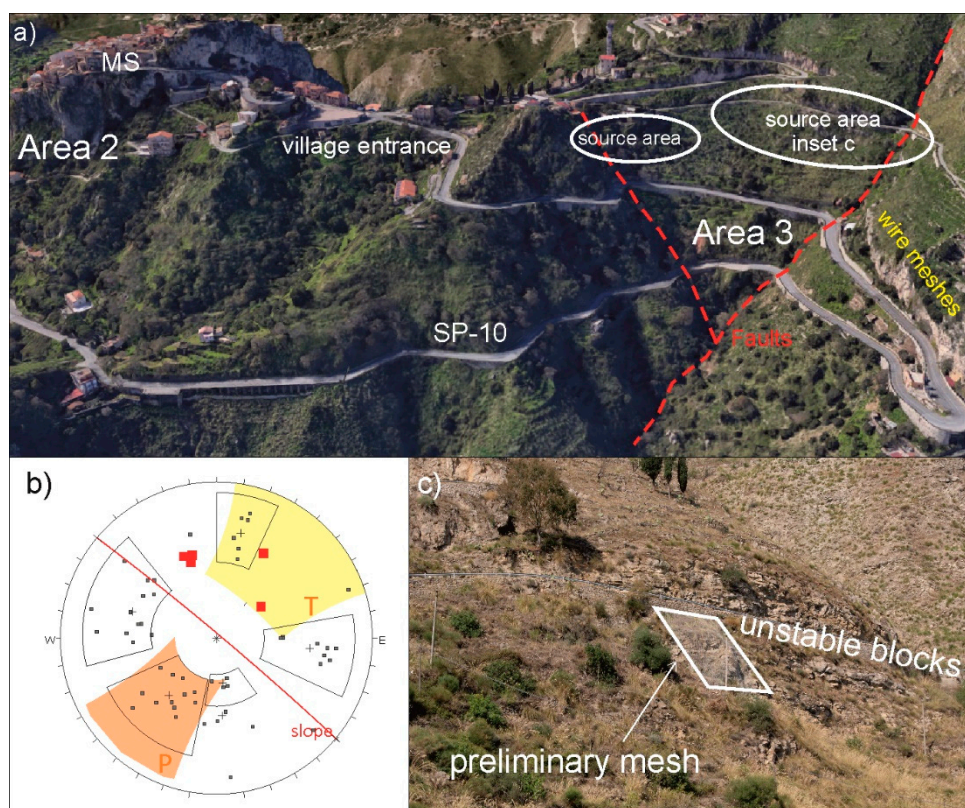
road is part of the tourist complex and it is the only tourist available path, we decided to include its northernmost sector (the one bordered by high carbonate dolostone and limestone cliffs) among the key areas of the Taormina complex and to apply the methodological approach of RRRS. According to [32], the structural setting of dolostones is characterized by 4–5 intersecting discontinuity systems (Figure 6b), with spacing ranging between 2 and 60 cm and openings from 0.1 to >5 mm. Fractures are generally filled with sand or calcite and show smooth or undulated surfaces, with a joint roughness coefficient (JRC) [53] ranging from 2 to 12. Analogously, limestones are crossed by four discontinuity systems, with apertures often >5 mm and JRC between 2 and 12. No considerable karst features have been surveyed in the outcrops of the study area. Slope height is between 30 and >60 m and the detachment zone is located at different altitudes. According to [37], the average block volume is 0.13 m^3 and there are some sectors of the slope already partially secured with wire meshes (Figure 6). Furthermore, tectonic structures cross this road segment, enhancing the weakness of the already poor rock masses (Figure 6a).

Figure 6. (a) 3D model of the area with main features reported: Main Square (MS), Provincial Road 10 (SP-10); (b) particular of a source area; (c) representative kinematic analysis of the source areas, (P-critical area for planar sliding, T-critical area for toppling, red squares are the intersection lines of unstable wedges).

The final assigned score is 51.75, corresponding to a medium risk area (Table 4). Despite the closeness with area 2, this mountain sector is characterized by a lower angle of slopes with a smoother morphology, along with a smaller block volume and the absence of karst features, resulting in a slightly lower final score.

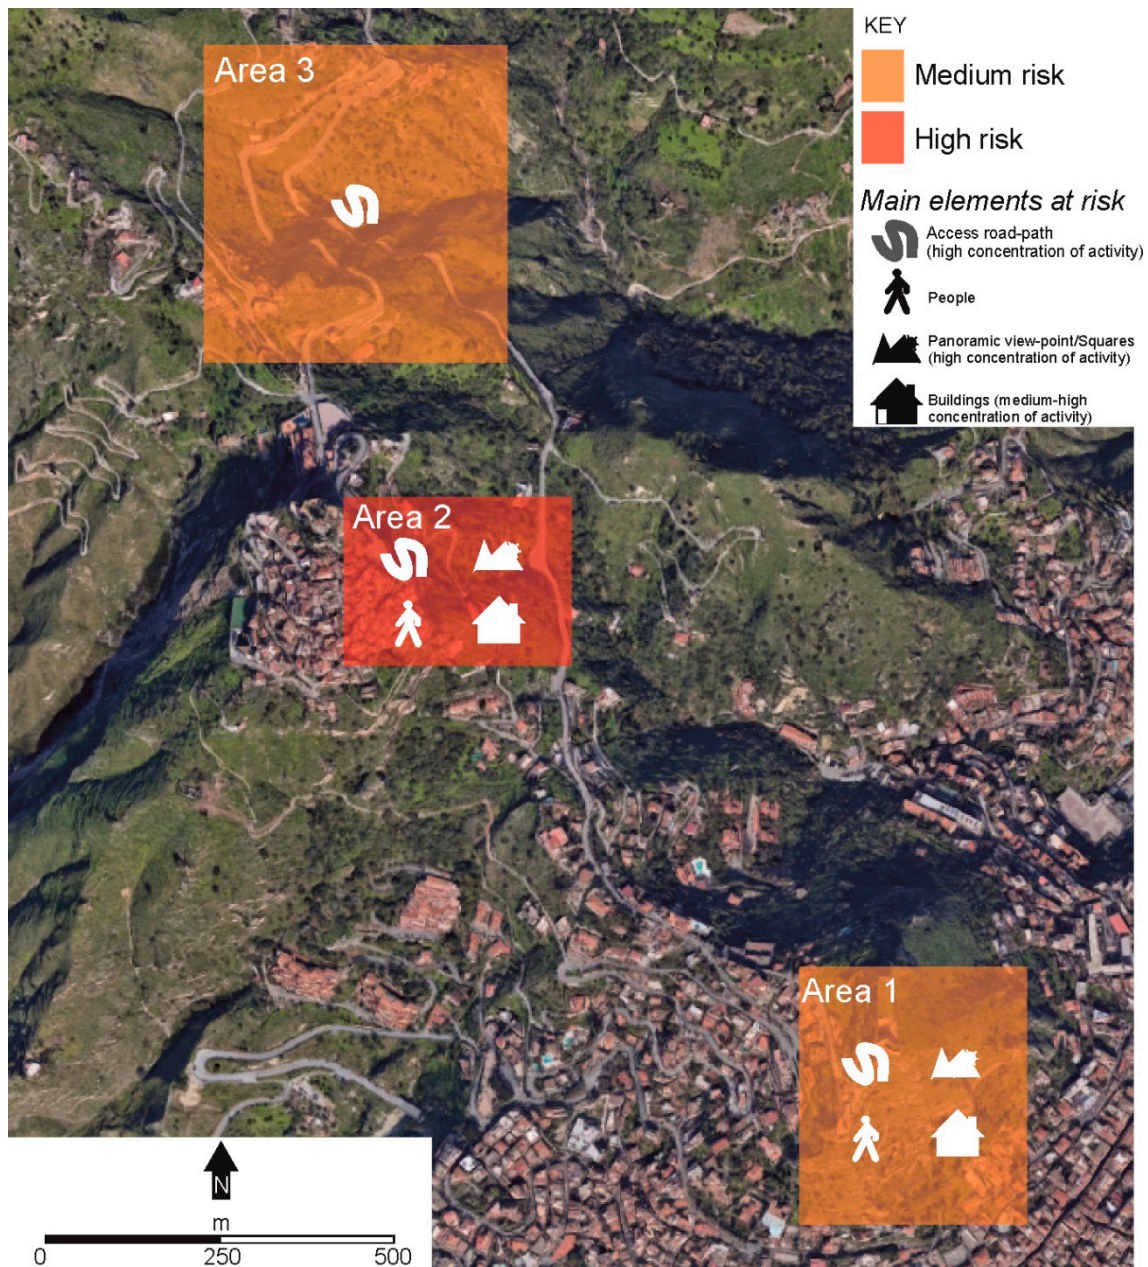
The final outcomes can be summarized in a thematic map, showing a different color according to the risk zonation and the main elements at risk (Figure 7), which could be used by the local administrators in the perspective of ensuring a sustainable fruition of the site. The whole procedure is quick, if historical and technical data are easily available, and does not require specific economic investments. This makes it suitable for a wide spectrum of cultural heritage in areas affected by rockfalls worldwide, where the need of an instrument that would lay the foundation for the beginning of a final securing is paramount for the sustainable fruition of the goods.

Figure 7. Rockfall risk map with location of the main elements at risk.
