IMAGES IN INTERVENTION

Embolization of Fractured Bioresorbable Scaffold Struts

Insights From 2- and 3-Dimensional Optical Coherence Tomography

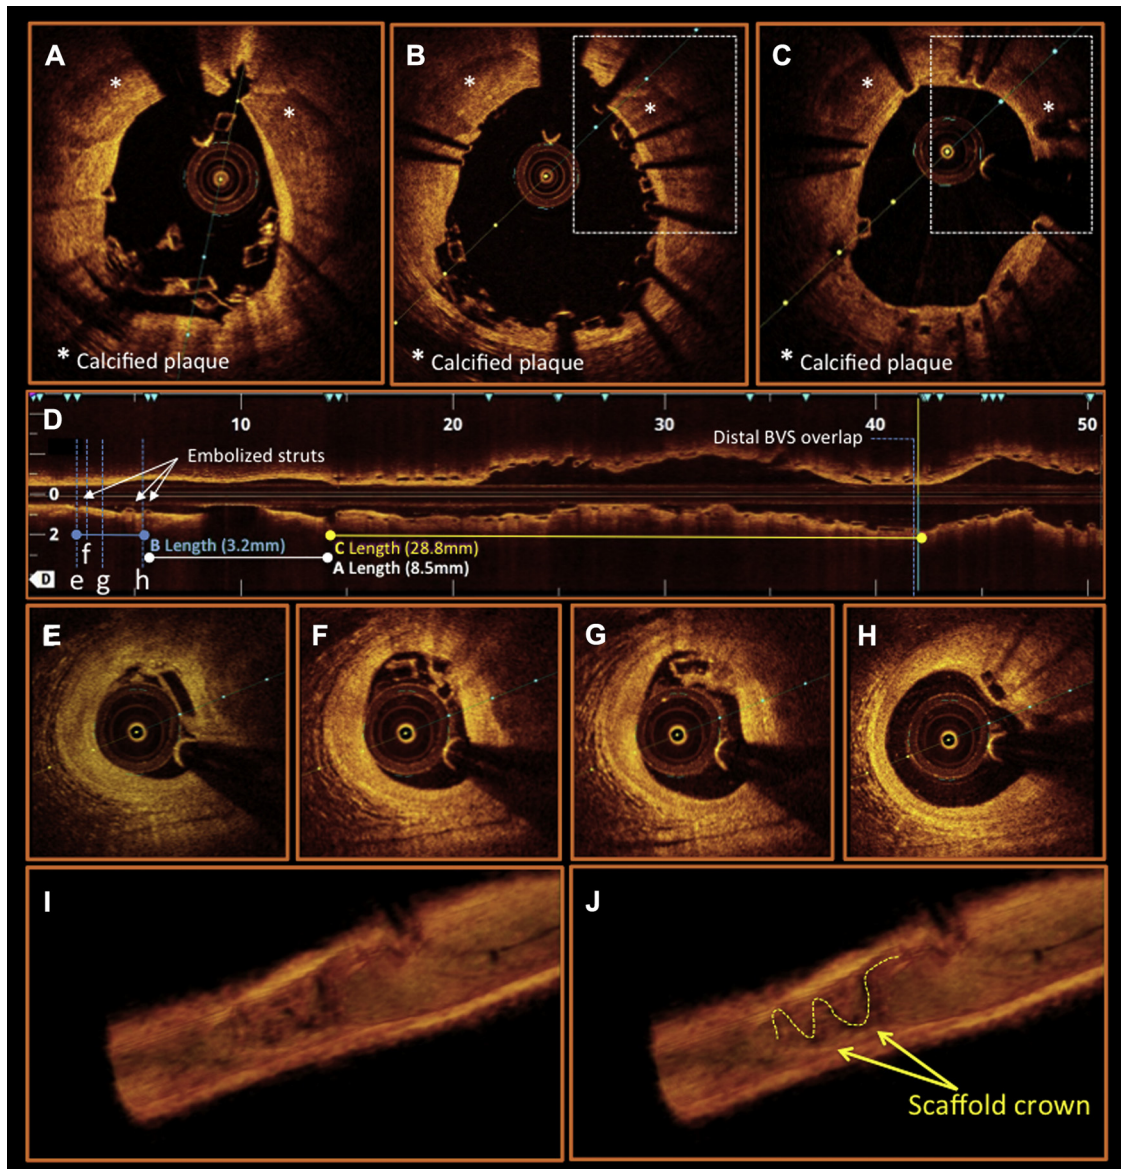
FIGURE 1 Fractured and Embolized Struts on 2- and 3-Dimensional OCT

A 58-year-old diabetic man underwent implantation of 3 overlapping Absorb bioresorbable vascular scaffolds (BVS) (2.5/28, 2.5/28, and 3.0/28 mm) (Abbott Vascular, Santa Clara, California) in a heavily calcified left anterior descending artery stenosis. Optical coherence tomography (OCT) revealed multiple fractures of the 3.0/28 BVS, leading to in-scaffold implantation of a zotarolimus-eluting stent (ZES) (Figures 1A and 1B). The 4-month angiography showed a severe edge in ZES restenosis treated with another stent. The OCT revealed an unexpected disappearance of BVS struts (Figure 1C) in the ZES segment and a nonocclusive cluster of polymeric struts stuck in the vessel wall 8.5-mm far from the distal scaffold, with various coverage patterns (Figures 1D to 1H). Three-dimensional OCT suggested a single fragment of polymeric crown (Figures 1I and 1J). The patient has not experienced adverse events over 8-month follow-up and never stopped dual antiplatelet therapy (DAPT).

This case provided a demonstration of strut embolization, which was an incidental OCT finding, showing that incorporation into the vessel wall rather than abrupt obstruction is a possible fate of embolized struts. This phenomenon may underlie late ischemic events, especially after DAPT discontinuation. It is conceivable that the metal-in-polymer technique might cause an additive stress on the BVS, likely inducing a scaffold fragments separation. Where the metal-in-polymer technique is used, an OCT may be appropriate to exclude scaffold embolization and guide DAPT duration.

Baseline 2-dimensional optical coherence tomography (OCT) shows the fractured scaffold (A) before and (B) after metallic stent implantation; the comparison between baseline (B) and 4-month (C) corresponding cross sections shows a focal disappearance at follow-up of BVS struts (dashed boxes). The longitudinal view (D) demonstrates the embolized strut cluster (B = 3.2 mm) and its gap (A = 8.5 mm) with the distal scaffold (C = 28.8 mm). (E to H) Cross sections show embolized struts partially covered (E), uncovered and protruding (F and G), or fully embedded (H). 3-dimensional OCT (I) demonstrates a longitudinal arrangement of a single fragment of scaffold crown highlighted in J (dashed yellow line).
