Is the Metallic Stent a Safe Treatment for Bioresorbable Scaffold Failure?

Insights From Optical Coherence Tomography

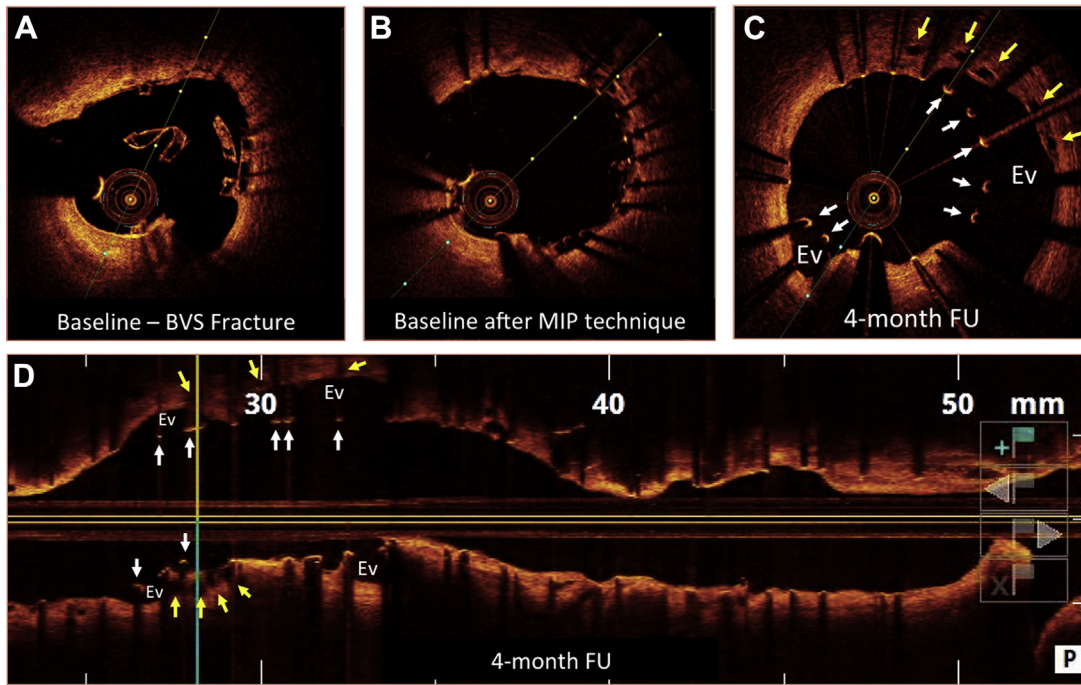
FIGURE 1 Baseline and 4-Month OCT Appearance of MIP Technique

A 58-year-old diabetic man with unstable angina underwent implantation in overlapping of 3 (2.5/28, 2.5/28, and 3.0/28 mm) Absorb bioresorbable vascular scaffolds (BVS) (Abbott Vascular, Santa Clara, California) in a long and heavily fibrocalcified left anterior descending artery stenosis. Post-implantation optical coherence tomography (OCT) showed a severe fracture of the proximal 3.0/28 mm BVS (**Figure 1A**) treated through the metal-in-polymer (MIP) technique with a conventional 3.0/30 mm drug-eluting stent (**Figure 1B**). Four months later because of effort angina a new angiography was performed; the OCT (**Figures 1C and 1D**) revealed multiple evaginations along the segment previously treated by MIP technique, with a different behavior between the metallic struts, which showed a large late-acquired malapposition, and the polymeric struts well apposed to the evaginated vessel wall; furthermore, while the nonapposed metallic struts were still uncovered, the disrupted scaffold struts were well covered and embedded into the vessel wall.

Same-level 2-dimensional optical coherence tomography (OCT) cross sections show the bioresorbable scaffold fracture (A) before and (B) after metallic stent implantation with well-apposed struts both metallic and polymeric; (C) cross-sectional view and (D) longitudinal view for the 4-month OCT assessment demonstrate the occurrence of late evaginations (Ev) with a different behavior between the metallic struts (white arrows), which appeared still uncovered with a relevant acquired malapposition, and the disrupted polymeric struts (yellow arrows), which conversely appeared embedded into the evaginated vessel wall. BVS = bioresorbable vascular scaffold; FU = follow-up; MIP = metal-in-polymer.

Metallic stent implantation represents a common treatment option for BVS failure, as acute struts fracture, to reduce the risk of future device-related events. However, our case shows that the positive remodeling or evaginations occurring after BVS implantation may lead to a progressive and persistent late-acquired malapposition of the metallic stent when the MIP technique is performed, providing a new trigger for late thrombosis. An OCT evaluation might be planned when MIP technique is used to rule-out a late malapposition before dual antiplatelet therapy discontinuation. Finally, alternative strategies, such as scaffold-in-scaffold implantation with another properly calibrated bioresorbable scaffold, might be considered for BVS failure.
