Article

Interdisciplinary Approaches to the Knowledge of Ancient Monuments: Integrating Archaeological, Archaeometric, and Historical Data to Reconstruct the Building History of the Benedictine Monastery of Catania

Heritage **2025**, *8*, 467. <https://doi.org/10.3390/heritage8110467>

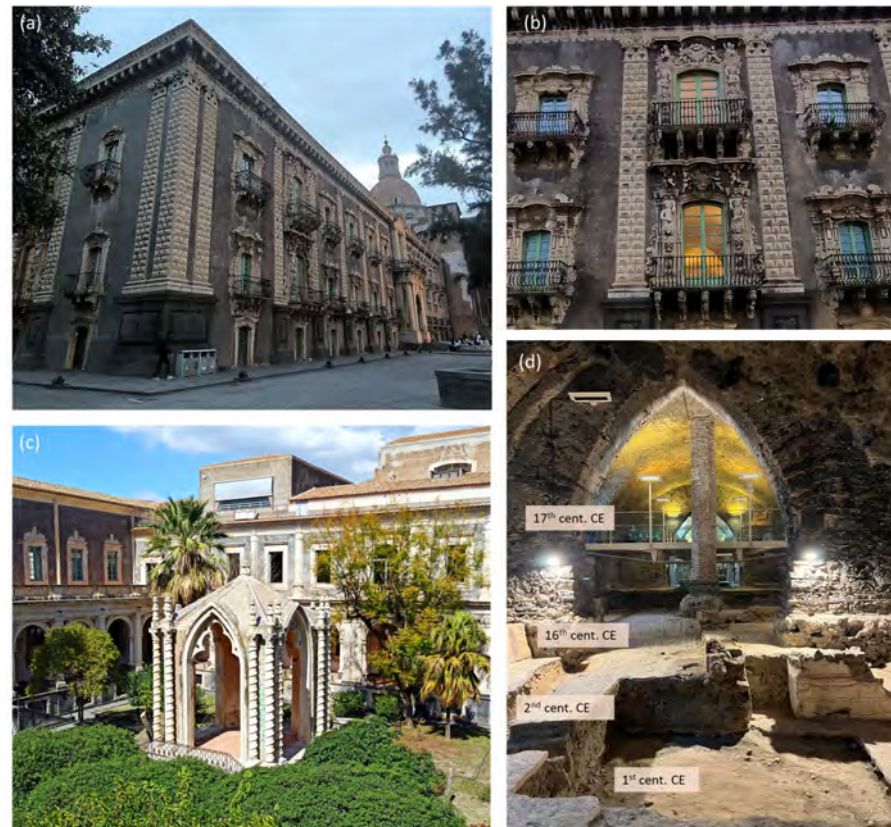
Figure 2. (a) General view of the main complex of the Benedictine Monastery; (b) particular of the baroque style; (c) eastern cloister and *Cafeas*; (d) view of the Roman domus as an example of historical multi-layered context.

The Benedictine Monastery complex represents an example of a multi-layered context of cultural heritage (as shown in Figure 2d, where the vertical succession of different construction phases in the Roman domus can be observed), suitable for the inter- and multi-disciplinary approach. It combines unlike contexts of artistic, historical, archaeological, and architectural interest, as well as different building/decorative materials and construction techniques used over time. It represents a key site for understanding not only the history of the monastery itself but also the broader history of the city of Catania [17]. Archaeological investigations carried out here from 1978 to 1996—marking the first urban stratigraphic excavations in the city—have provided extraordinary data, allowing direct insight into the city's history. Beneath the courtyards and the monastery's massive foundations lies a true stratigraphic and architectural palimpsest, capable of offering exceptional information: a continuous, detailed testimony that traces the history of this site from prehistory to the modern and contemporary periods [18].

From the 3rd century BCE to the 2nd century CE, the hill hosted an extensive residential quarter [22]. Notable is the Hellenistic “*Casa della tavola imbandita*,” in use until the 1st century CE (Figure 2d), decorated with painted plaster, tessellated floors, and *opus scutulatum* pavements [24]. In the Roman phase, continuity of habitation is confirmed by houses along *Cardo I*. A peristyle domus, built over the earlier Hellenistic house, preserves three porticoed sides, wall paintings, and rich mosaics [22,24,25] (Figure 2d). The Dionysian grid remained in use until the 6th–7th centuries, when it was progressively replaced by modest dwellings and irregular lanes, marking early medieval decline [22,26].

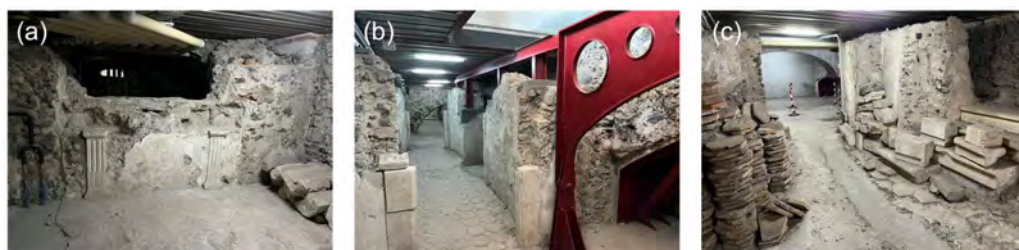
Figure 3. Investigated areas within the library deposits: (a) ante-refectory room; (b) refectory room; (c) sacristy.

A specific area of the building, now accessible from the storage rooms of the current library, was chosen to carry out the investigations and studies. In particular, such area was selected because it preserves coexisting materials from different periods in a largely unaltered state. Being located in disused spaces with restricted public access, it remains undisturbed, allowing us to perform in situ analyses and, where appropriate, collect samples for subsequent laboratory investigations. This area, called “ancient refectory” belongs to the original 16th–17th century structure, later abandoned after the renovations following the 1693 earthquake. The area is situated near what was the first floor of the northern arm of the western body, as well as the original nucleus of the monastery before the post-earthquake transformations of 1693 (Figure 1c,d). This area was dedicated to shared activities and comprises the “ante-refectory room” (a), the “refectory room” (b), and the “sacristy” (c) (Figure 3a–c).

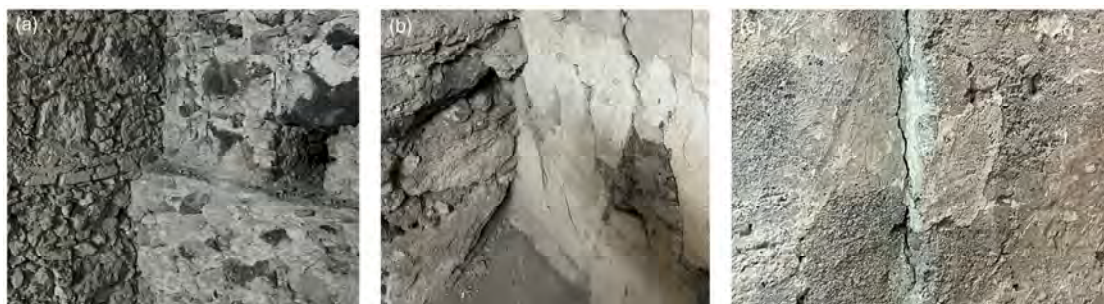
Figure 5. Three different examples of contact points between walls stratigraphic units: (a) USM 7 up USM 3; (b) USM 19 up USM 1; (c) USM 11 up USM 8.

For each unit, the stratigraphic relationships (contemporaneity, anteriority, and posteriority) with adjacent units were documented through detailed analysis of contact points and a careful examination of the placement of materials (Figure 5).

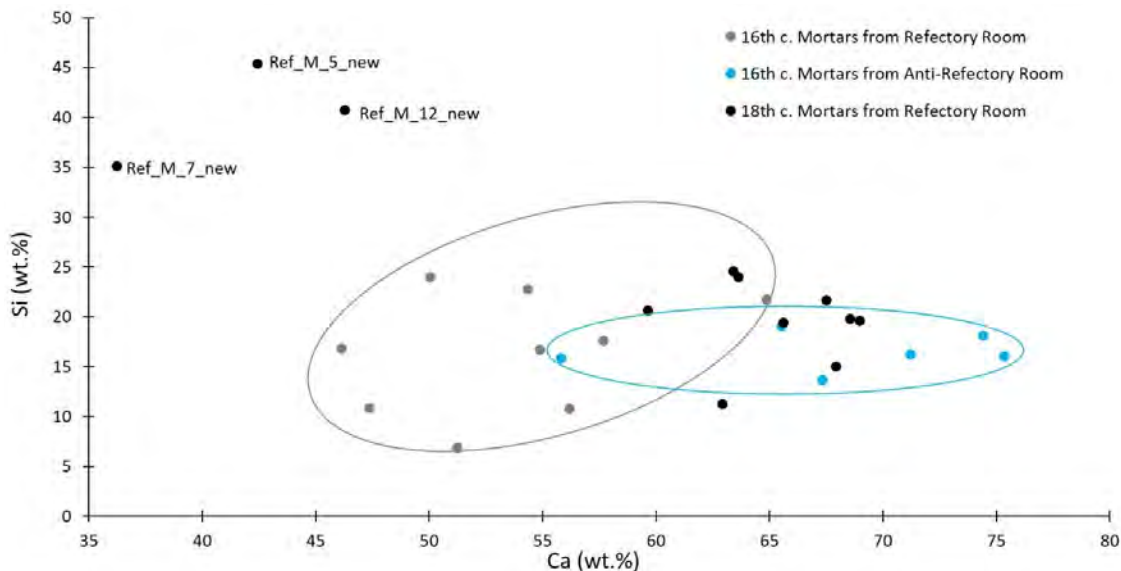
Figure 12. Portable X-ray Fluorescence analyses on mortars, Ca (wt.%) vs. Si (wt.%) values measured on mortars of pre- and post-earthquake walls in refectory room and pre-earthquake walls of the ante-refectory.

Regarding the mortars, the data collected from the surface show an elemental composition dominated by calcium (up to 75 wt.%) and silicon (Si) (up to 45 wt.%), with some points also rich in sulfur. Aluminum appears to be another important element in mortars, with content ranging between 4 and 16 wt.%. A slight variation sees the mortars from ante-refectory bearing a higher calcium content compared to those from the refectory room (Figure 12). The graph of Figure 12 also shows the distribution of the measurements acquired on mortars dated back to 16th and 18th centuries, particularly of the refectory room. Except for the samples Ref_M_5_new, Ref_M_7_new, and Ref_M_12_new, the obtained

results do not indicate significant compositional differences among the mortars sampled from different historical periods (Table 1). The abovementioned samples, instead, are clustered with a higher silicon content and lower calcium. These three points can indicate the presence of mortars with different characteristics within the same reconstruction, namely after the earthquake.
