UNIVERSITY OF CATANIA

Ph. D. COURSE
"EVALUATION AND MITIGATION OF URBAN AND LAND RISKS"
XXXII CYCLE

BIOTA IMPACT ON LEVEE STABILITY

ECOHYDRAULIC EVALUATION OF LEVEE FAILURE MECHANISMS AND REMEDIATION TECHNIQUES

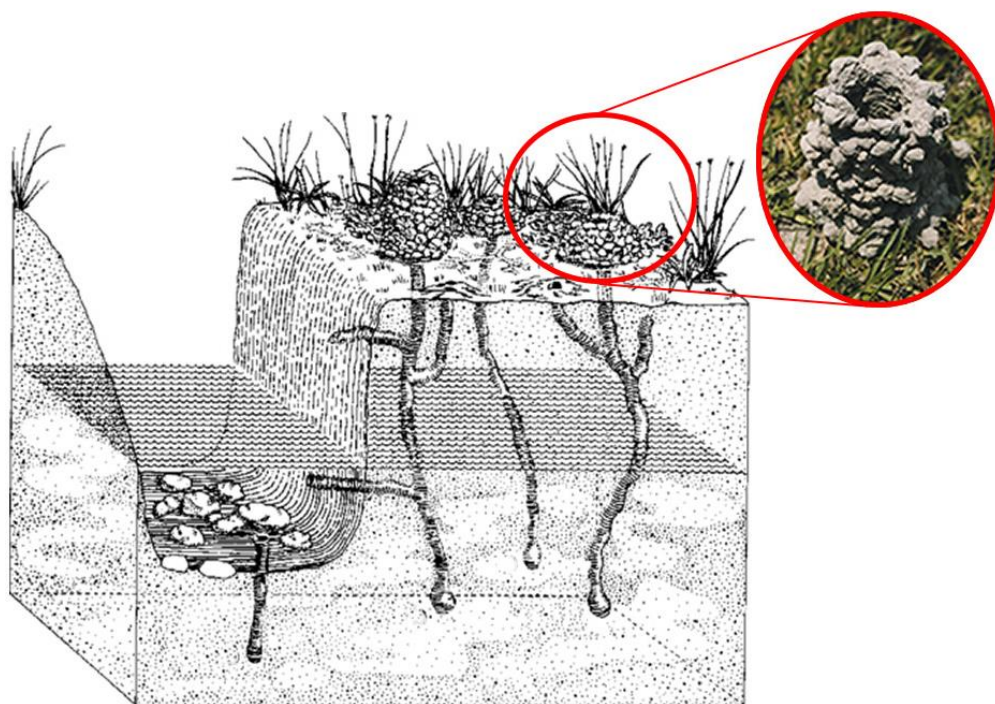
Figure 3-2: Crayfish burrows and the typical “chimney” made with mud pellets [adapted from Hobbs et Lodge, 2010].

as a resting habitat during molting and inactive periods. Actually, these animals stay in their burrows or in mud bottoms during cold weather but emerge once the water warms up [Helfrich et al., 2001]. Moreover, they burrow on both the landside and waterside slope of the levee, along the shore line their tunnels are 0,60 to 5,00 cm in diameter with a cone-shaped mound, known as a “chimney”, plugging the burrow, as shown in Figure 3-2.

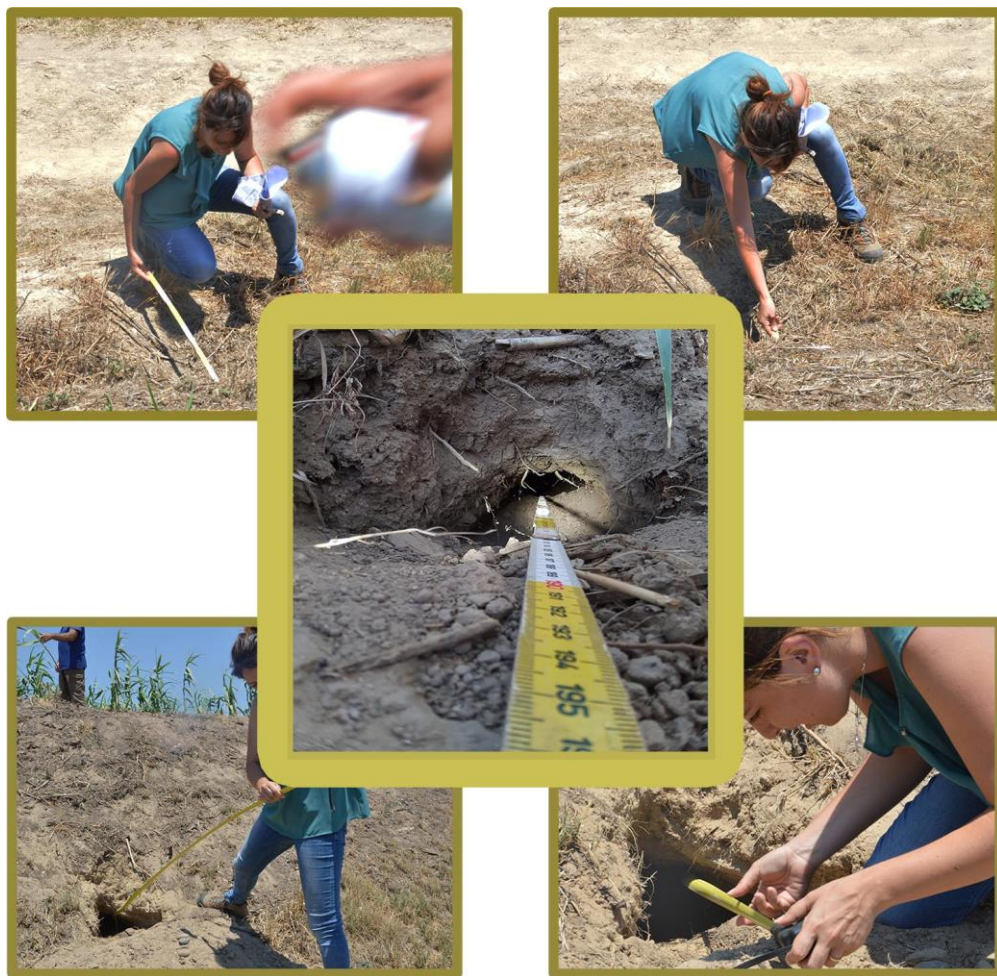
Figure 4-26: On-site investigation and burrow depth analyses.

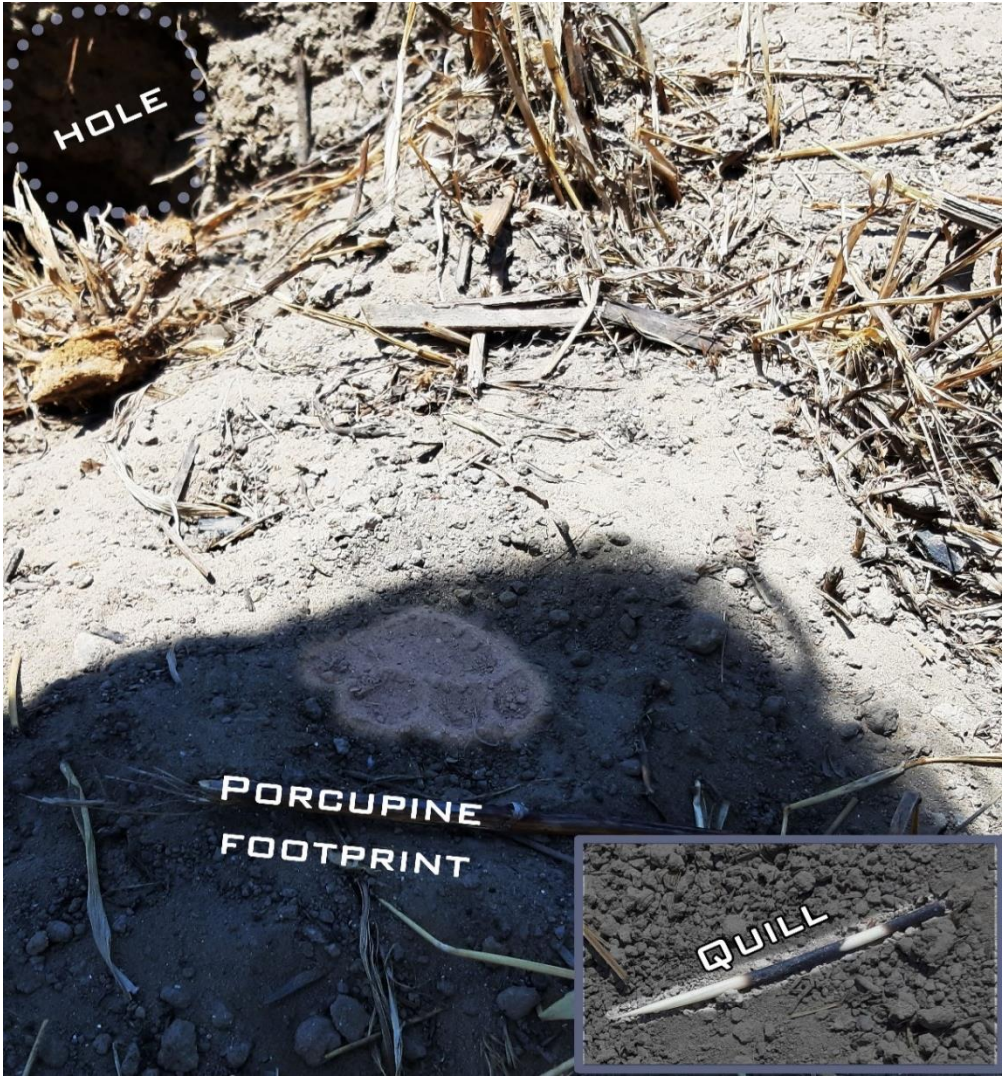
Figure 4-27: Field evidence of the presence of burrowing animals: porcupine footprint and quill near hole no.6.

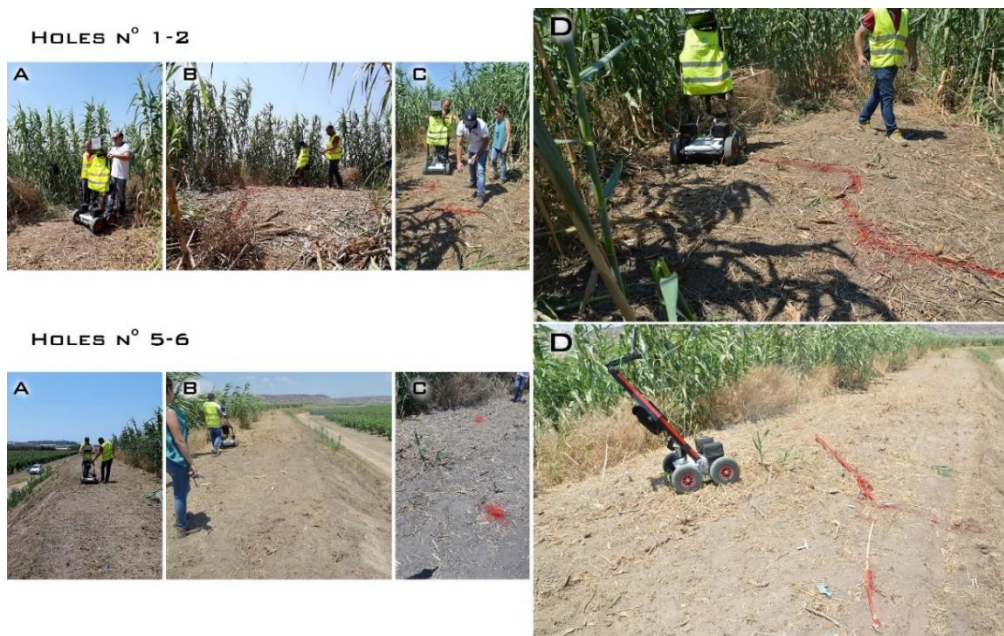
Figure 4-29: GPR survey for holes 1-2 and 5-6:
A) GPR position on the levee crest;
B) GPR scans;
C) Record soil discontinuity;
D) Reconstruction of burrow path inside the levee.

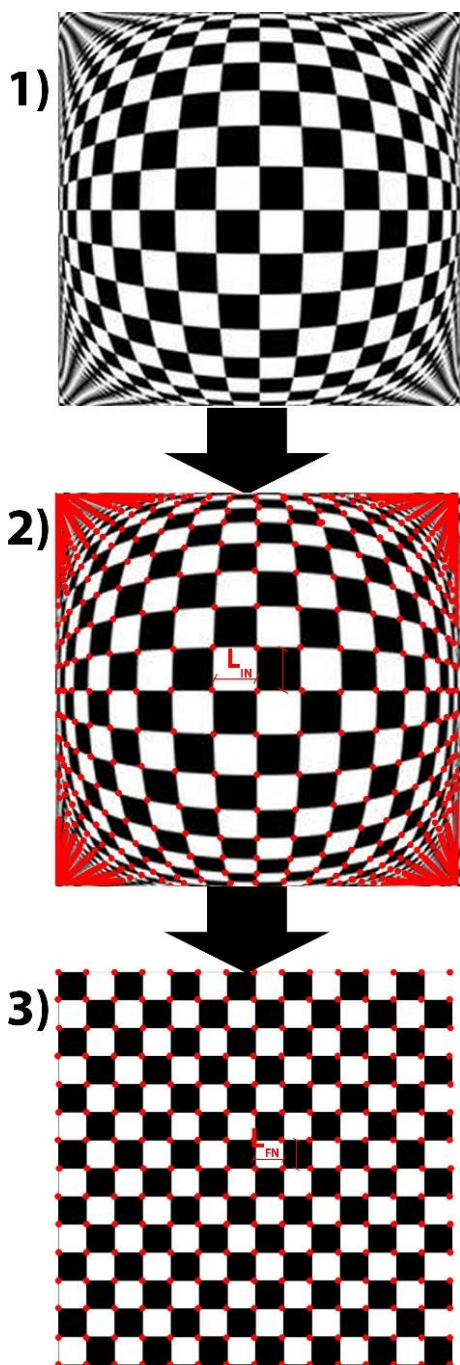
Figure 5-10: 1) Photograph of the checkerboard;
2) Determination of square limits;
3) Changing and homologation of square dimensions, after rectifying the photos.

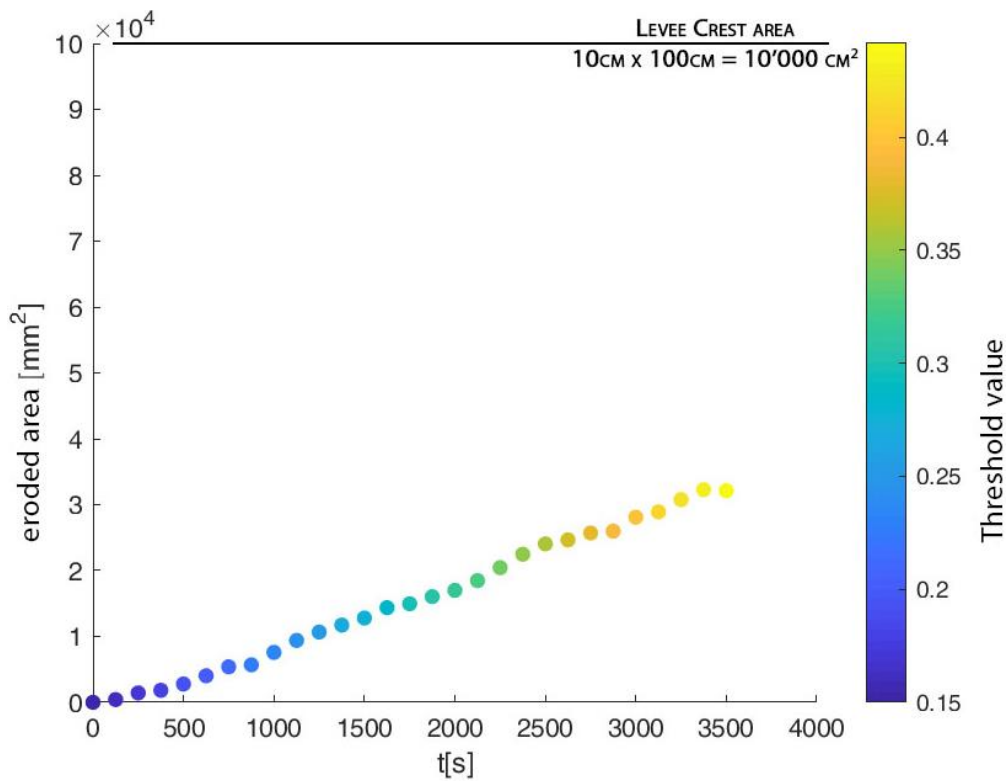
Figure 5-14: Measurement of eroded area for all the frames of a single experiment gauged by increasing the threshold value with the increase of eroded area. The threshold value applied on a frame is indicated by the colorbar on the right. The threshold value range is from 0.15 to 0.45.

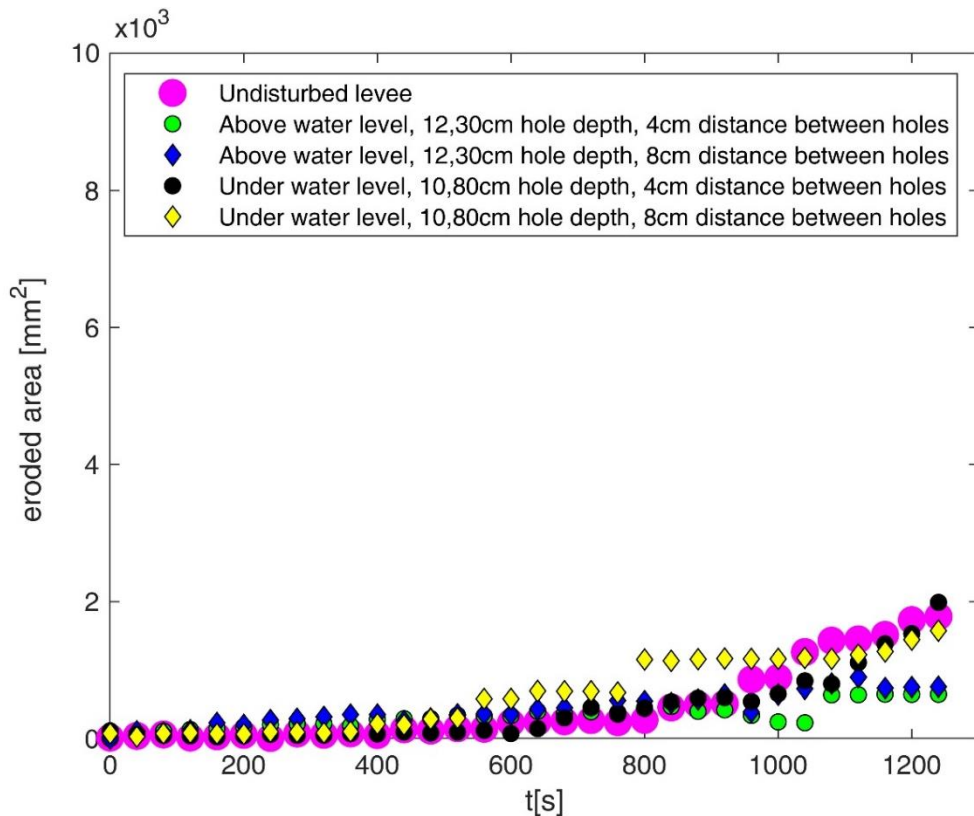
Figure 6-4: Experimental test of 90° inclination holes referred to the water flow.

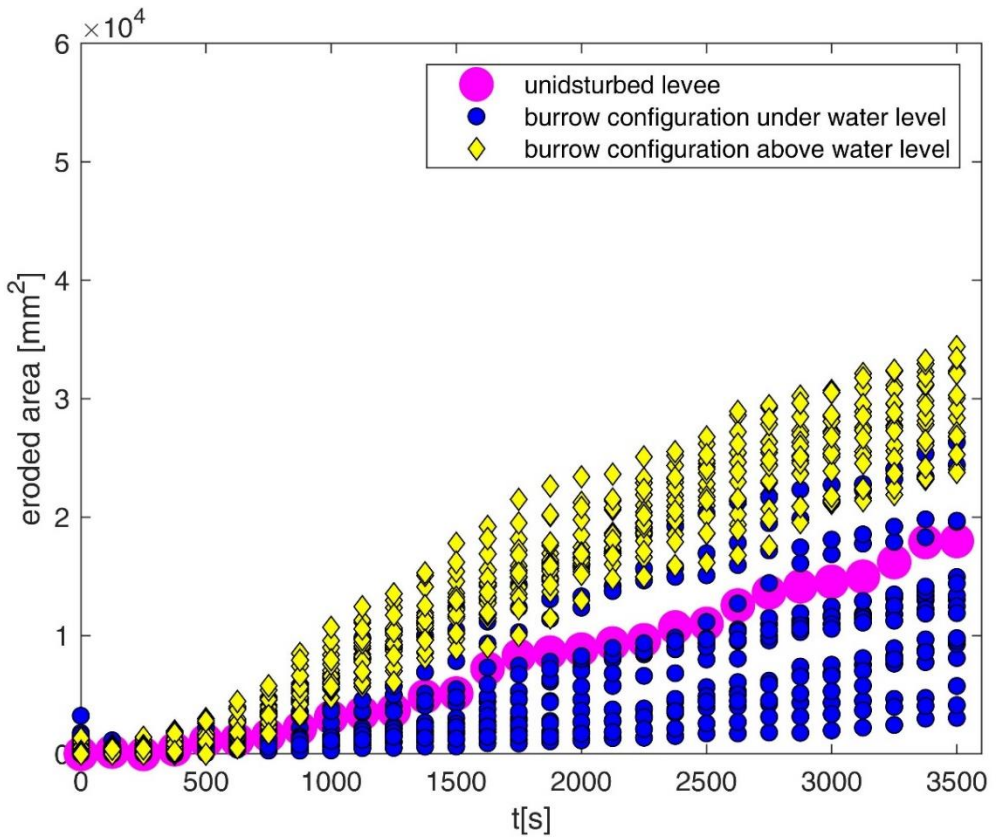
Figure 6-7: Comparison between all the configuration above (yellow) and under water level (blue) and the undisturbed levee benchmark.

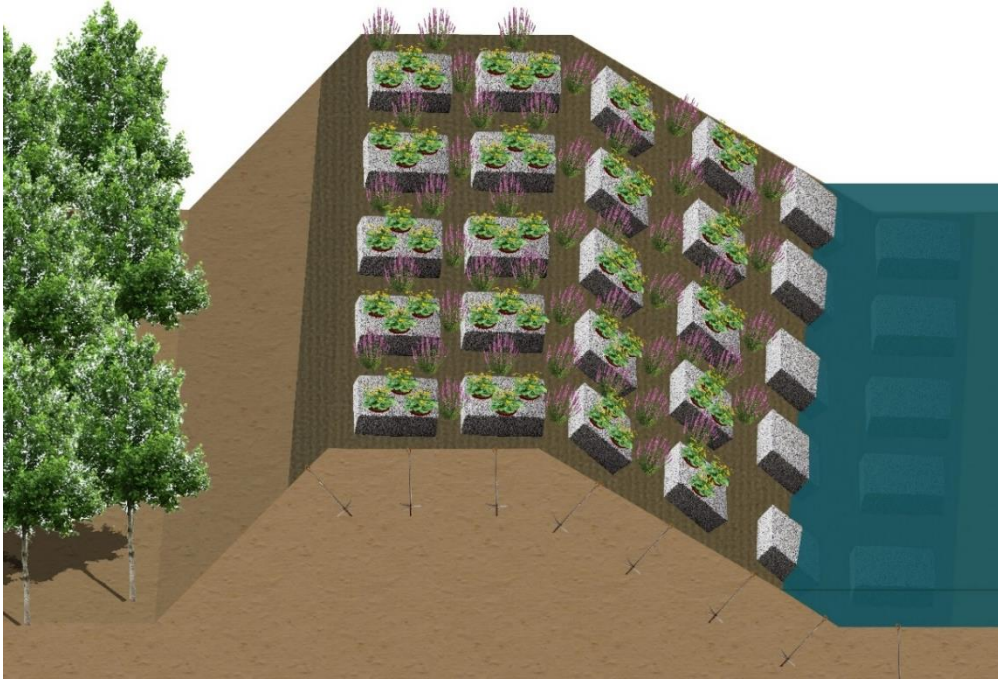
Figure 7-33: Hypothetical application of Trevimat to improve the earth levee stability.
