# An Interpretive Ruination Model of the Built Heritage in Inner Areas: The Case Study of the Neighbourhood Granforte in Leonforte

Deborah Sanzaro, Maria Rosa Trovato \*

Department of Civil Engineering and Architecture, University of Catania, 95124 Catania, Italy; deborah.sanzaro@phd.unict.it (D.S.); chiara.circo@unict.it (C.C.)

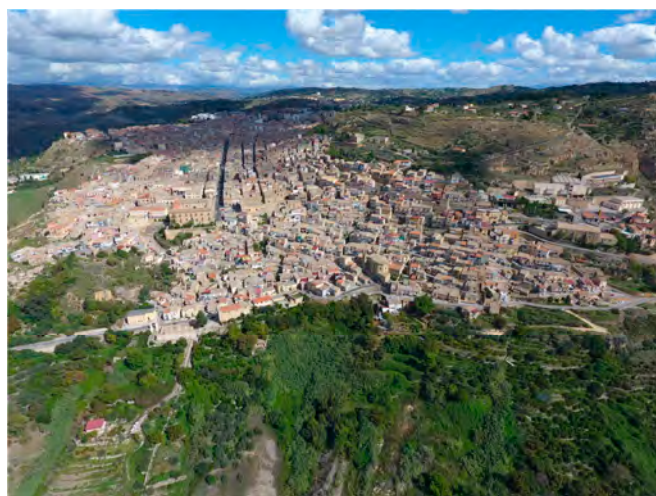
**Figure 1.** Aerial view of the southern slope of the town. The interaction between nature and the built environment characterises the southern edge of the town.

Leonforte is developed on the slopes of Mount Cernigliere with a linear structure that is strongly constrained by the orographic situation (Figure 1). The oldest neighbourhoods are concentrated to the south and are characterised by a compact built-up area that absorbed the contained demographic growth until the beginning of the 20th century; to the north-east, the most recent expansion appears to instead be marked by a growing urban and commercial sprawl. In the face of a cohesive population decline observable since the post-World War II period [57], a condition of imbalance between the different parts of the city is noted. In fact, while the northern area and its anonymous suburbs remain more attractive and densely populated, the southern edge, corresponding to the oldest area, is in a condition of progressive abandonment and decay (Figure 2). In this context, the historical Granfonte neighbourhood appears as an urban periphery located on the fringes of a larger land periphery. In the neighbourhood, the recognition of the qualities and values of historic buildings is struggling to emerge in the awareness of the community. Thus, the ruined buildings, which are increasingly numerous in the neighbourhood, are perceived as evidence of the disinterest of public actors who have so far not initiated any strategic action for the recovery of the historical town.

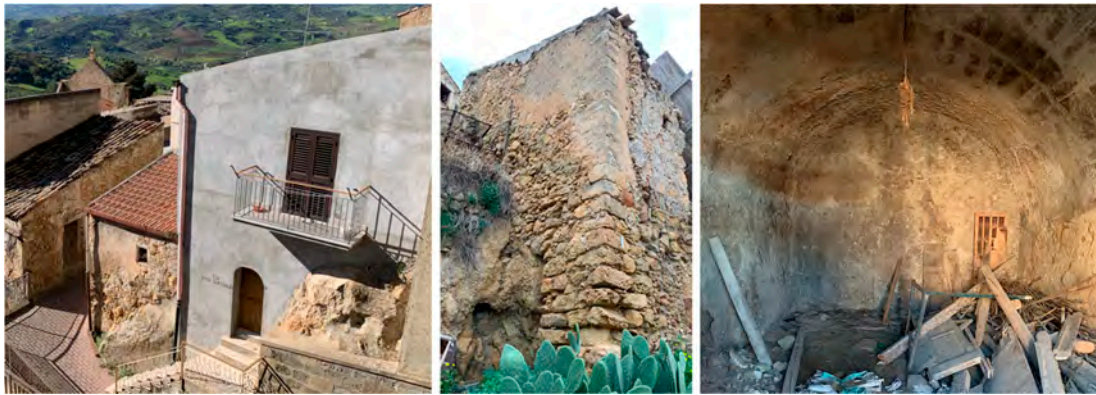
**Figure 3.** Examples of dwellings built against the rock outcrop. Depending on the ground conditions, the rock outcrop is often an integral part of the elevation walls. Walls are often built directly on natural rock outcrops; similarly, vaults may have a part directly carved into the rock.

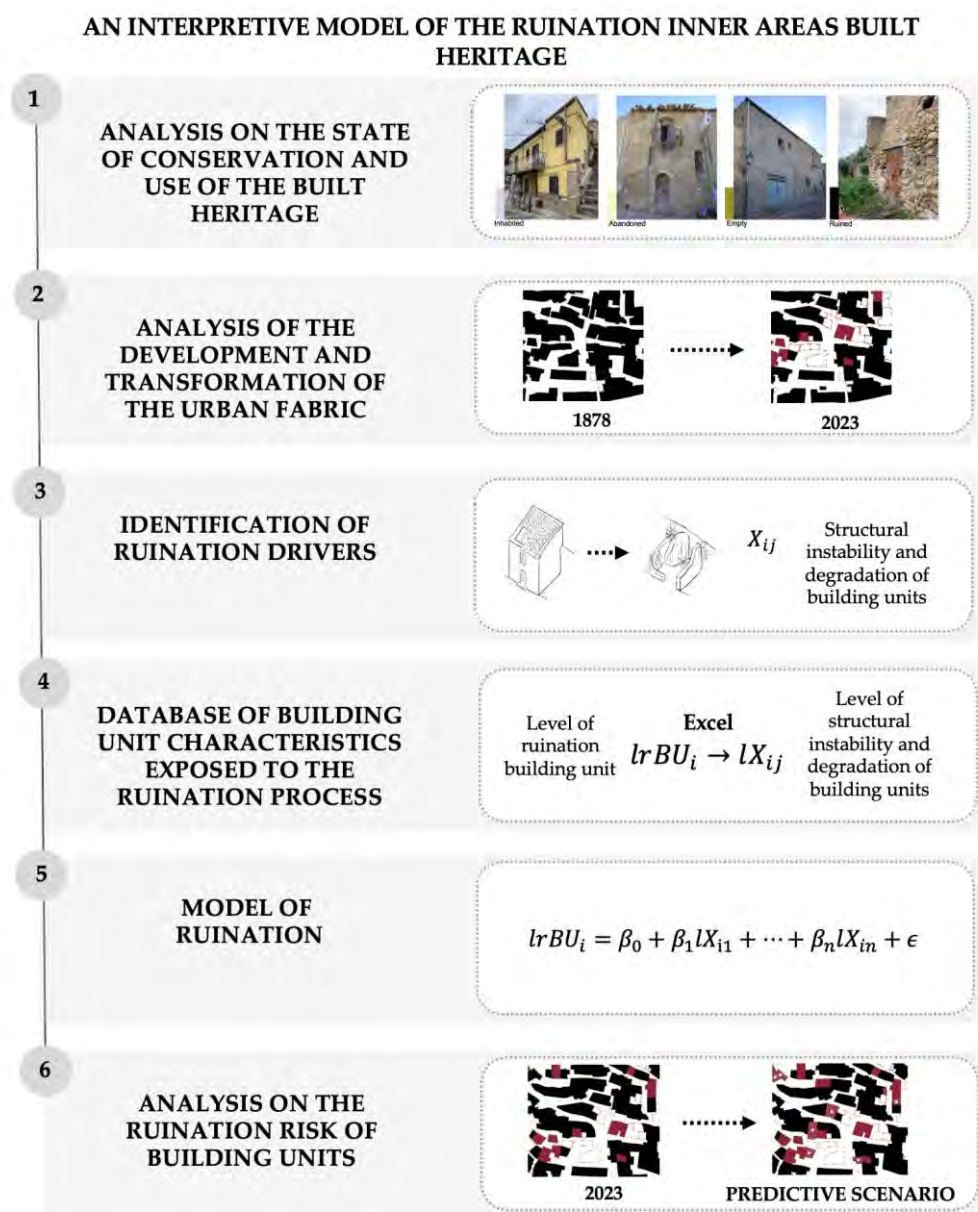
**Figure 4.** Flowchart of the methodological approach.

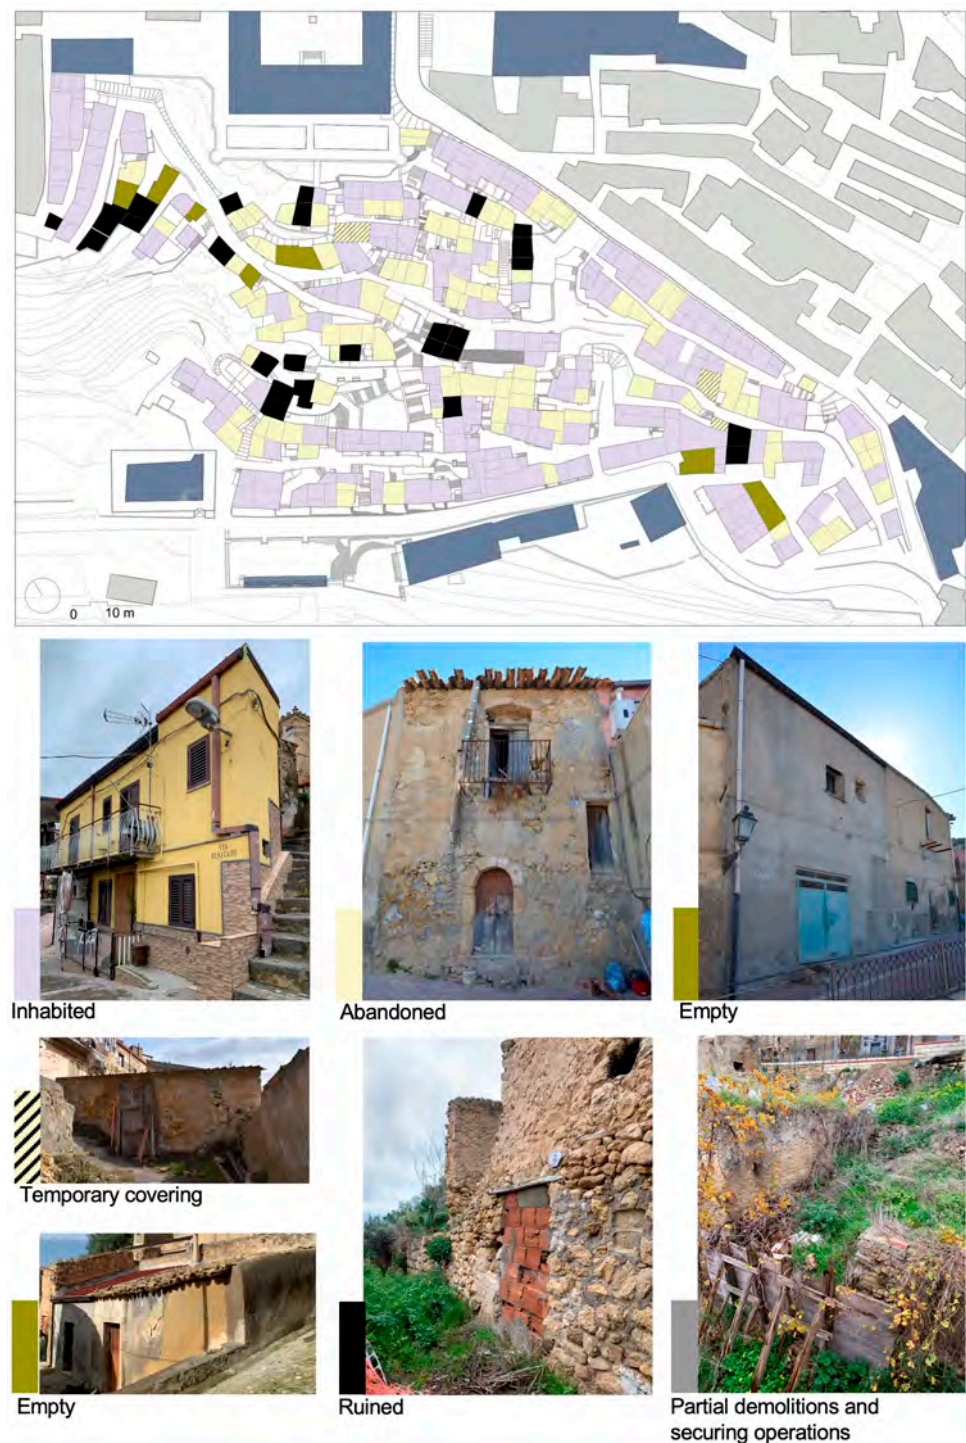
**Figure 5.** Survey of buildings according to their use and state of conservation. The analysis reveals a lack of homogeneity of conditions in the historic neighbourhood (our elaboration).

The close reading of the urban fabric has made it possible to assess the actual repercussions of the marginalisation phenomenon on the historic built-up area. The analysis of the building use reveals a diversified scenario corresponding to the evident fragmentation of residence: there are buildings in good condition and still inhabited—but often heavily transformed—alternated by empty, abandoned, and even ruined buildings. This investigation, shown in Figure 5, thus clearly highlights the partially abandoned condition of the neighbourhood; in fact, abandoned dwellings account for about half of the total. The critical reading of the building fabric has also made it possible to identify the presence of some building units that should already be considered as in a state of ruin according to the classification adopted here, as they have roof collapses of more than 50%. Some of these appear to be affected by processes of a more advanced ruination as they are involved in serious structural instability. On the other hand, a few building units had a provisional roof following the collapse of the original one.

The observation of the distribution of abandoned and ruined buildings highlights certain peculiarities of the residential vacancy. If the abandonment—and sometimes the subsequent phase of advanced ruination—appears to be mainly scattered in the fringe blocks, it is more extensive in the heart of the neighbourhood.

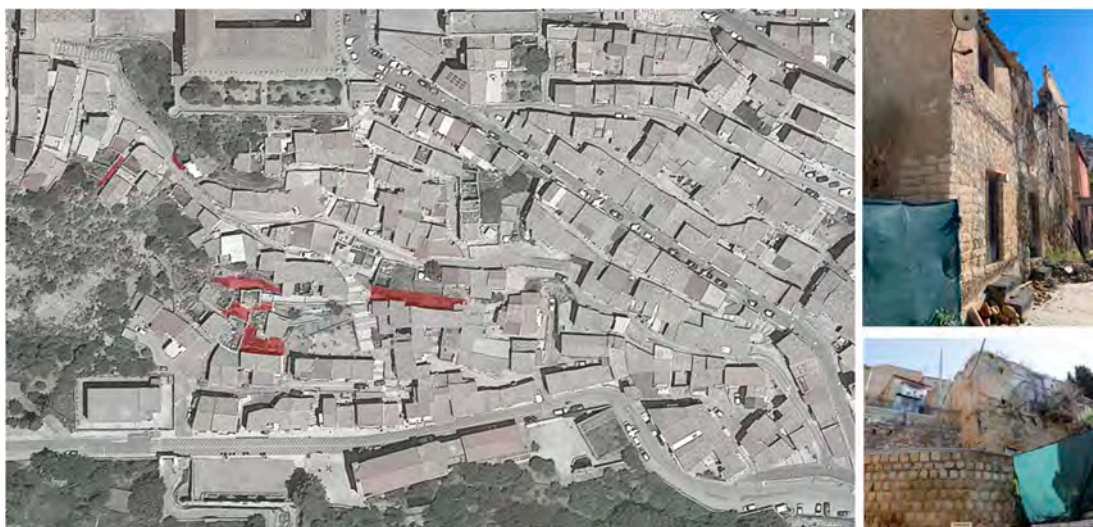
**Figure 6.** Roads and urban areas inaccessible for security reasons (our elaboration).

The analytical filing carried out after the field work revealed important criticalities. For example, in the case of more complex aggregative conditions and progressive densification and superelevation, while the upper levels are still permanently inhabited, those downstream are in a state of abandonment for reasons stemming not only from ownership fragmentation but also from poor accessibility or lack of light and air. In such a scenario, the lower floors that are in a condition of prolonged abandonment may even present structural instabilities, which are sometimes resolved using hasty consolidation operations. This is aggravated by the presence of superelevation structures that continue to be inhabited. Abandonment thus generates multiple risk situations with repercussions on both the stability of the buildings involved and those adjacent and on the safety of public routes. The clearly precarious conditions have indeed forced the closure of some roads, but the instability of many buildings continues to represent a vulnus for the entire urban environment (Figure 6).

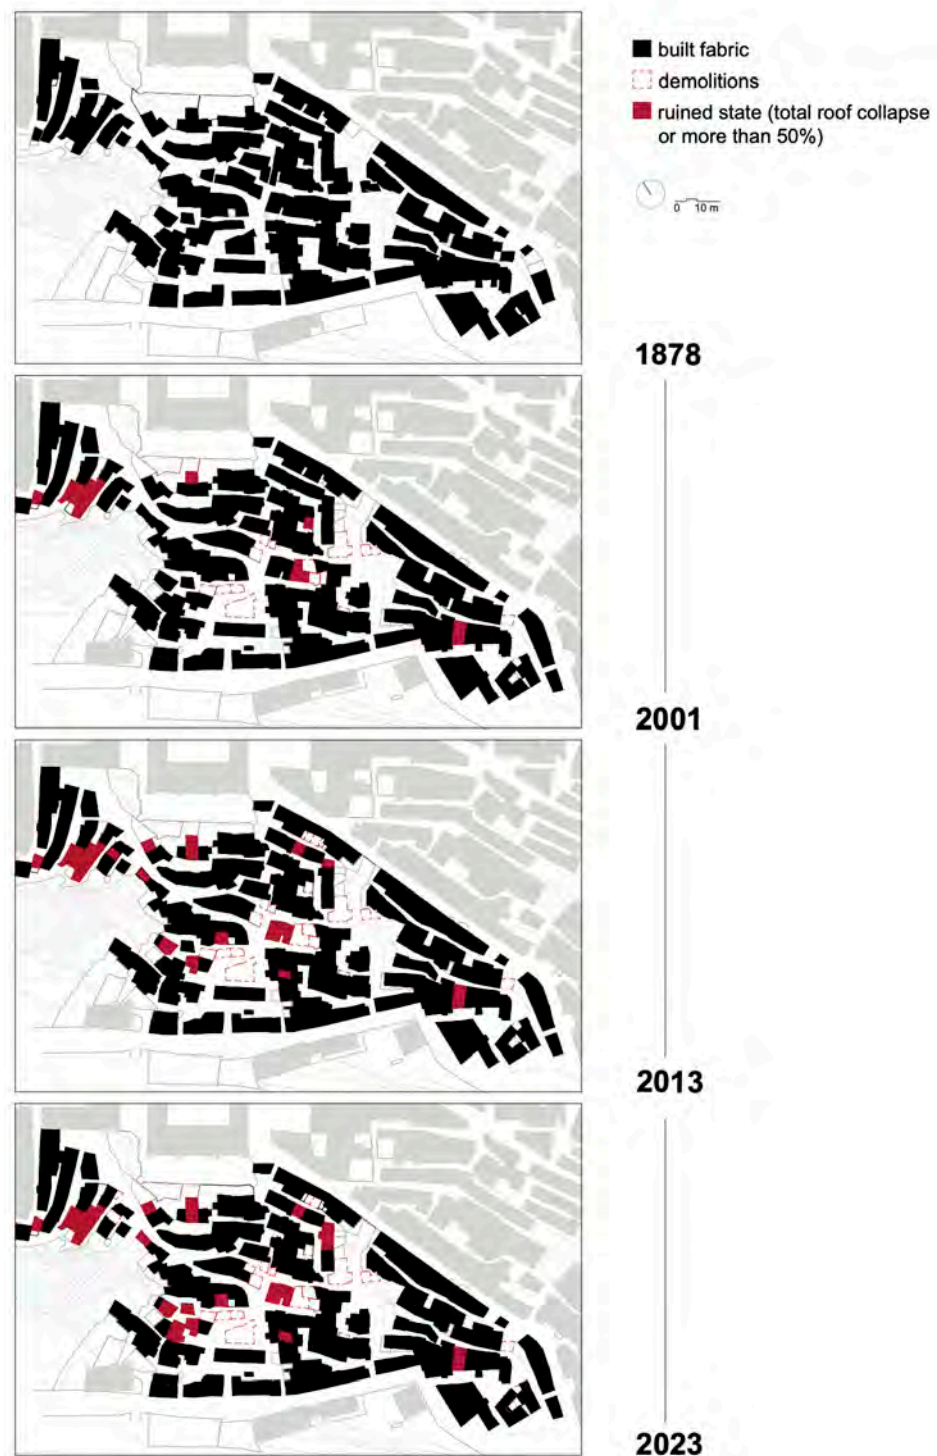
**Figure 7.** The built fabric from 1878 to the current situation shows the progress of ruination and, contextually, demolitions. Redrawn on the basis of the current cadastral map. The maps summarise the comparison of historical photographs areas available on the Regional Territorial Information System (RTIS) and on Google Earth, dated 2000, 2006, 2010, 2013, 2016, 2017, and 2022 (our elaboration).

The starting point for the analysis of the ruination process is the cadastral map of 1878. The critical restitution of this map on the basis of the current cadastre led to the recognition of the built areas that have retained an unaltered conformation until today. It is reasonable to assume that at this date, the neighbourhood was very dynamic and free of derelict areas and ruins. The 2001 census already showed that, similarly to what was found for abandonment, ruins also tend to be concentrated in certain areas, forming clusters. In particular, the upper part of the neighbourhood shows a conspicuous presence of ruined buildings that are concentrated particularly at the end of the blind street. Similarly, the aggregate at the bottom, also a dead-end street, approaches becoming a second cluster of ruins alternating with heavily structurally compromised buildings. The condition observed in 2013 clearly appears to have worsened. On the one hand, the number of ruined buildings increases in the vicinity of the two areas already affected by the phenomenon; on the other hand, the process of ruination advances, involving new areas. The snapshot to 2023 shows the extent to which the steady growth of ruined buildings is now a blight on the neighbourhood.

A comparison of the maps shows that, in addition to the rapid advancement of ruination, demolition is practised. Some areas are thus threatened not only by the rapid increase in ruins but also by the progressive (and definitive) loss of built fabric. The aerial photographs show that the collapse of even partial roofs most often constitutes a point of no return; in such situations, recovery or reconstruction are rare, and the building starts a process of incremental decay only mildly counteracted by the placement of a temporary covering. The next step is the total or partial demolition of unsafe parts justified on public safety grounds. The ordinances issued in recent years by the Municipality for reasons of public safety oblige owners to make buildings safe by demolishing unsafe parts and reinforcing the remaining structures. In actual practice, these interventions have been carried out without any particular care and even using mechanical means; some building units with serious structural instability have suffered such damage and collapse that they have (more or less justifiably) led to their total demolition.

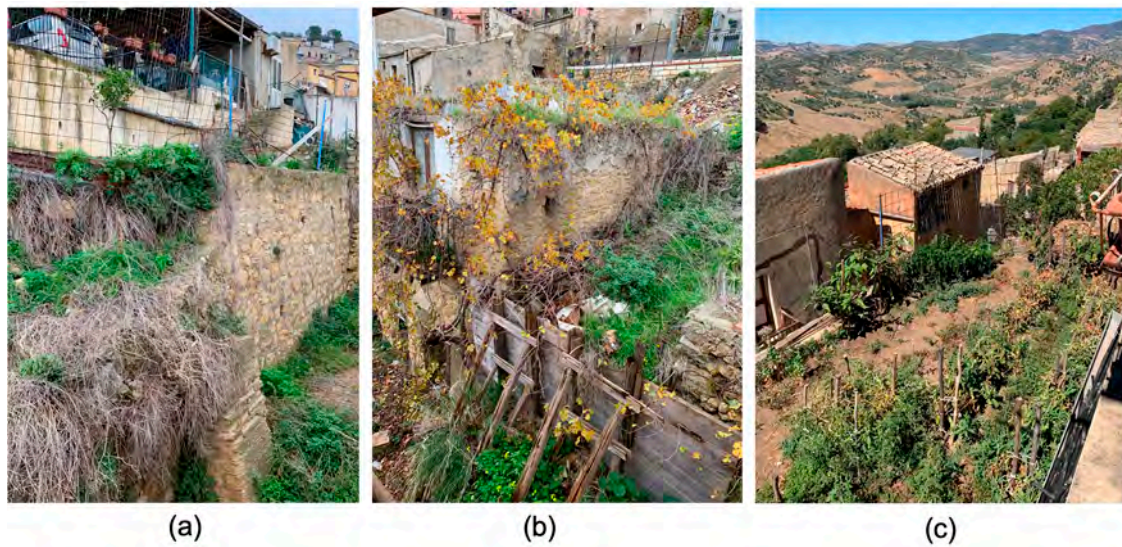
**Figure 8.** Partial demolition and securing along and between vico Vitale and via Riscato. (a,b) The downstream situation shows the provisional shoring and partial reconstruction of the retaining wall. (c) Upstream situation with the use of the infilled area as a private vegetable garden.

In addition to demolition, there is an alternative way of securing the ruins. Following their partial demolition, the buildings have been filled with rubble and waste; they have then been used as supports for terraces and belvederes or as car parks or have been transformed into private vegetable gardens. In this sense, the intervention carried out between vico Vitale and via Riscato is emblematic (Figure 8). The volumes of the houses on the slope, now devoid of roofs, were filled with soil and rubble, following the precarious secur-

ing of the facade walls downstream. This intervention is a symptom of an inappropriate way of dealing with the problem of ruins. In fact, in addition to definitively erasing the traces of pre-existing buildings, it is an inadequately designed consolidation operation that does not even ensure a safe response to the new function of being a retaining wall.

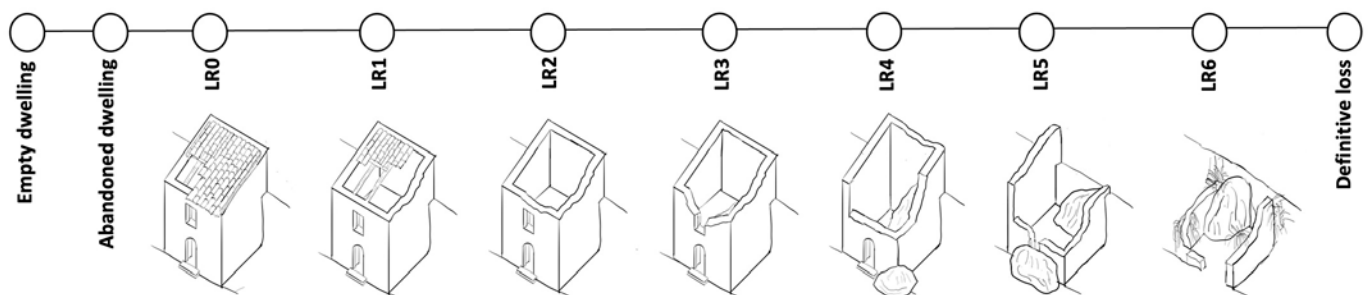
**Figure 9.** Scheme of the ruination process (our elaboration).

Following the diachronic reading, the survey of all ruined buildings inventoried allowed us to typify the phases of ruination (Figure 9). We schematised it into seven damage configurations, expressing the progressive degeneration of the building in ruin until it reached the state of collapse and total ruination. The reconstruction of this process considered two main parameters that are easily detectable from the outside: the extent of the collapse of the roofs and walls. For the more advanced stages, we added another parameter concerning the collapse of internal structures and floors.

The first configuration identified is LR0 and concerns buildings affected by deterioration and minor roof or wall collapses, e.g., at openings made close to the guttering line. The on-site analysis made it possible to identify several forms that may be part of the initiation phase of the ruination process. The shapes identified may vary depending on the construction sequence as well as the inherent vulnerabilities [81,82].

Phase LR3 involves the first collapses of the perimeter load-bearing walls, which is followed by phase LR4, in which more extensive collapses of the walls and the total collapse of the internal floors may also occur. It is worth pointing out, however, that the collapse of floors is a mode of damage that can also affect buildings that still have roofs. These are most frequently metal floors; only occasionally has the collapse of the barrel vault been verified. Phase LR5 is characterised by a very extensive collapse, which may affect the reading of the

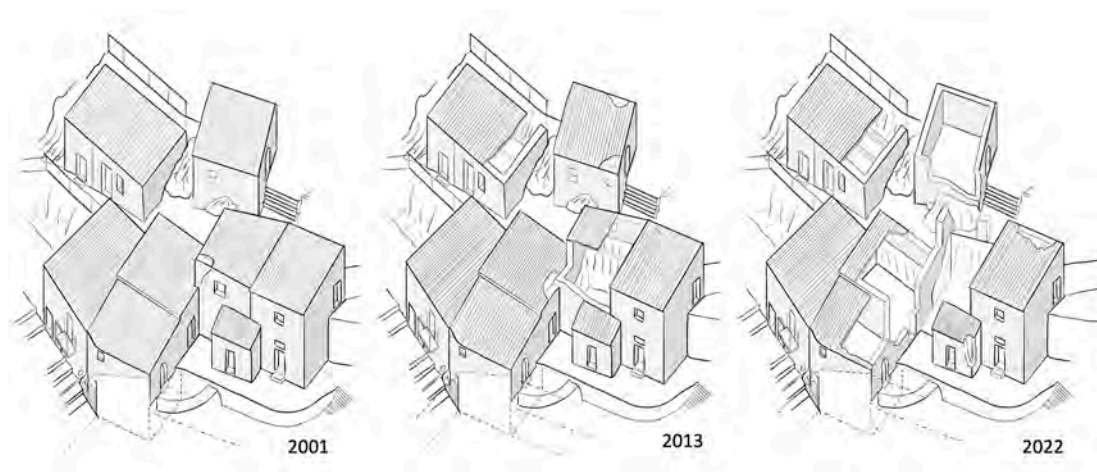
**Figure 10.** Study on the progress of collapses in an aggregate. In 2001, the building unit in the centre of the aggregate was affected by a first minor collapse. In 2013, the process advanced with the collapse of the corner and part of the façade and the first damage on the adjacent unit. The contiguity to a ruin has therefore induced the collapse of the roofs of the adjacent unit. In 2022, there is a progression of collapses that now also extends to the lower cell with which the unit shares a load-bearing wall. At present, the unit at the far end, adjacent to the first ruin, also shows marked signs of decay that attest to the beginning of ruination (our elaboration).

The study of the evolution of the phenomenon shows that these mechanisms may depend on the construction sequence or be amplified by the presence of intrinsic weaknesses (Figure 10). The position of the openings made close to the masonry ridge represents a vulnerability. This results in a thin masonry portion that constitutes a weakening of the top of the façade. The position adjacent to a ruin can increase the risk of collapse of the top portion of the wall in case of loss of the roof. The extensive collapse of roofs may also weaken the shared wall and induce further collapses of the roofs or floors of adjoining cells. These mechanisms also occur in cases where the extensive collapse of the façade wall leads to the expulsion, even partial, of an incorporated cornerstone, triggering the collapse of a wall portion of the contiguous building. Moreover, as the collapse in the first unit progresses, the adjacent unit will be exposed to an increasing risk of collapse with respect to the shared wall.

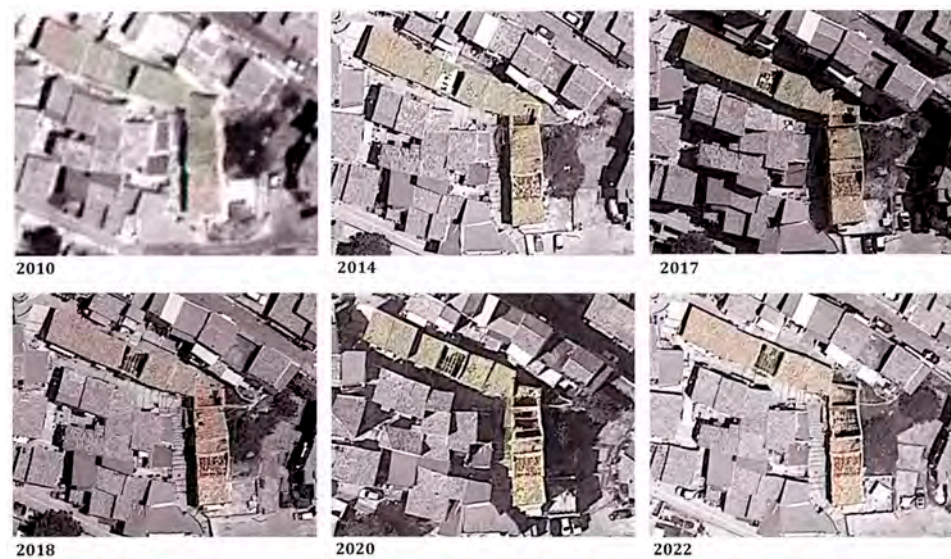
**Figure 11.** The progress of the collapse along via Cassarà. Elaboration based on area photographs from SITR and Google Earth (our elaboration).

The aerial photographs show the progression of the phenomenon just described. This is clear in the aggregate along via Cassarà. The extensive collapse of the roof of the corner cell, which acts as a link between the two parts of the aggregate, was followed by the collapse—at first minor and then extensive—of the roofs of the adjacent cells (Figure 11).

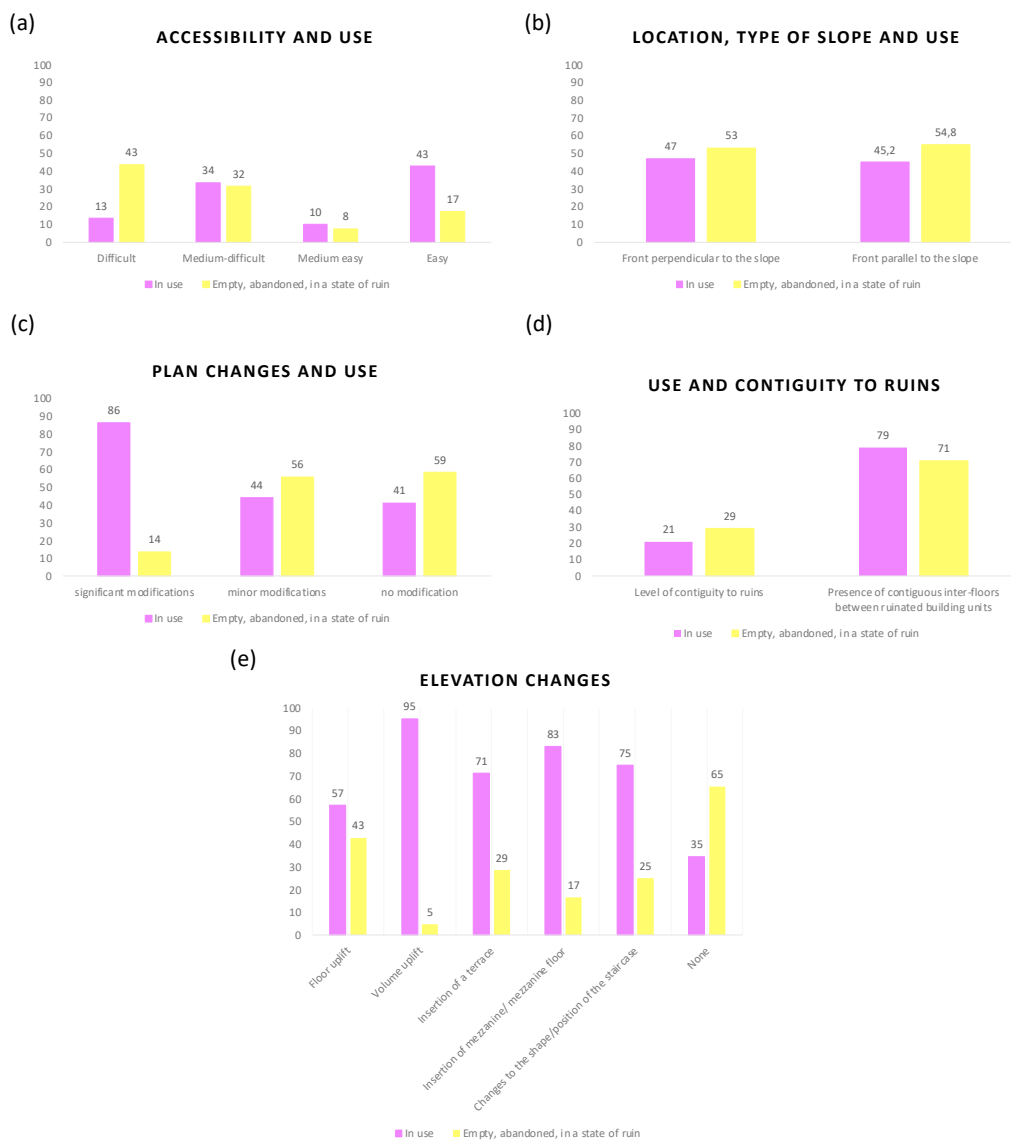
**Figure 12.** Relationship between the conservation and use conditions and certain settlement and architectonic characteristics of the building unit (our elaboration).

The first noticeable condition is the marginalisation of specific areas due to difficult accessibility. Figure 12a shows that the more accessible building units tend to be more inhabited, while the less accessible are generally empty, abandoned, or in a state of ruin. Figure 12b highlights how the relationship with the slope can influence the condition of use of the building unit. Figure 12c,e show a prevalence of elevation and planimetric transformations in building units in use, while those that are transformed are in a state of abandonment or ruin. Figure 12d highlights the relationship between the contiguity to ruins and the abandonment or ruination of building units.

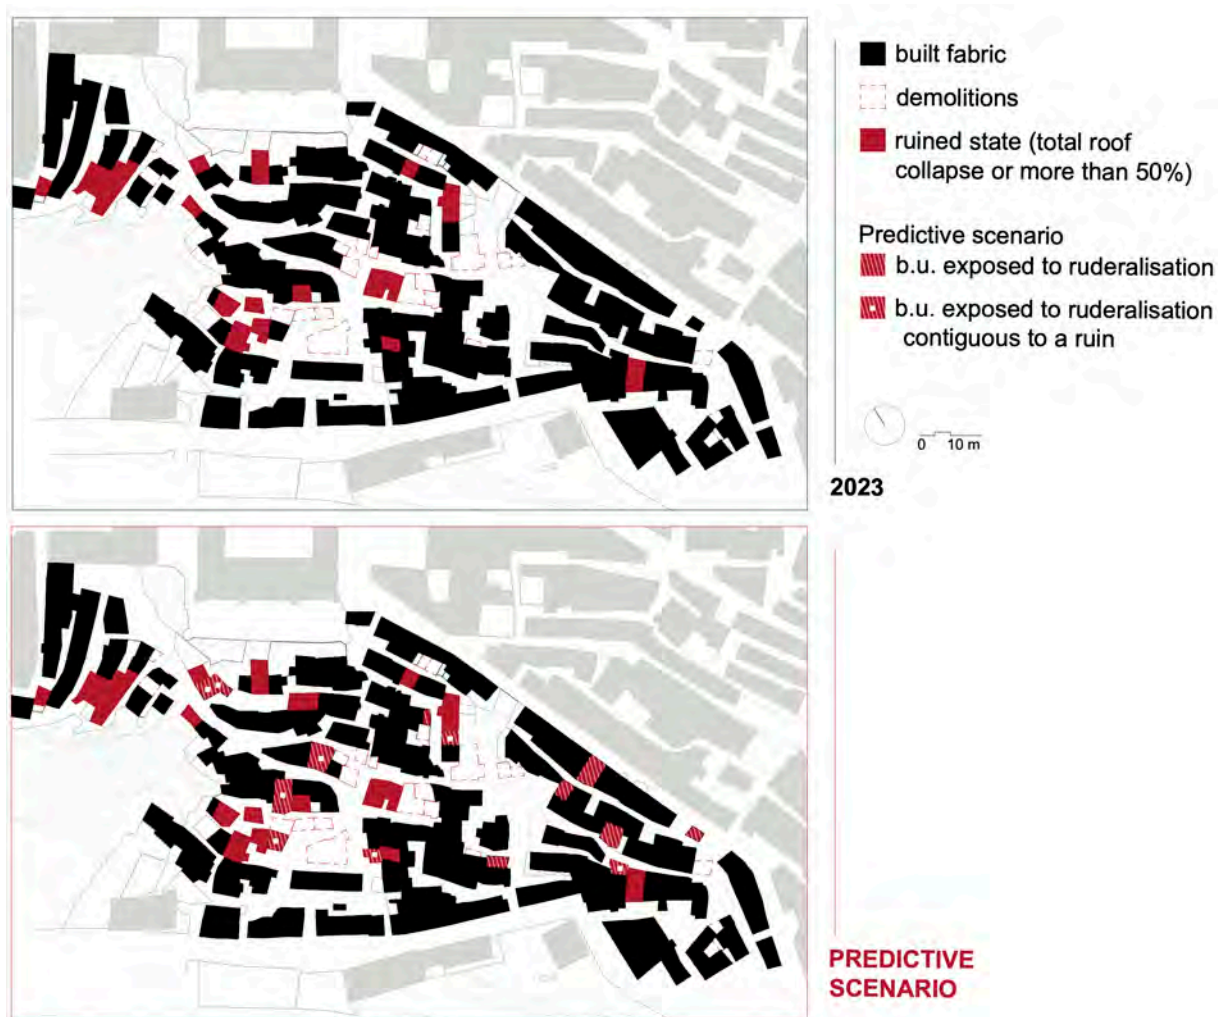
**Figure 13.** Comparison of the ruination phenomenon between the current and forecast scenarios.

Figure 13 takes up the study of the evolution of abandonment and ruination, proposing a comparison between the current state of ruination of building units and the forecast state as generated on the basis of the estimated model results.

The model shows a prediction scenario in which the state of ruination of some building units also extends to adjacent ones, i.e., the cases highlighted with the hatching in Figure 13. This scenario shows how some building units that are not currently affected by the ruination phenomenon will be affected in the future, i.e., the cases highlighted with a white square in the same figure.

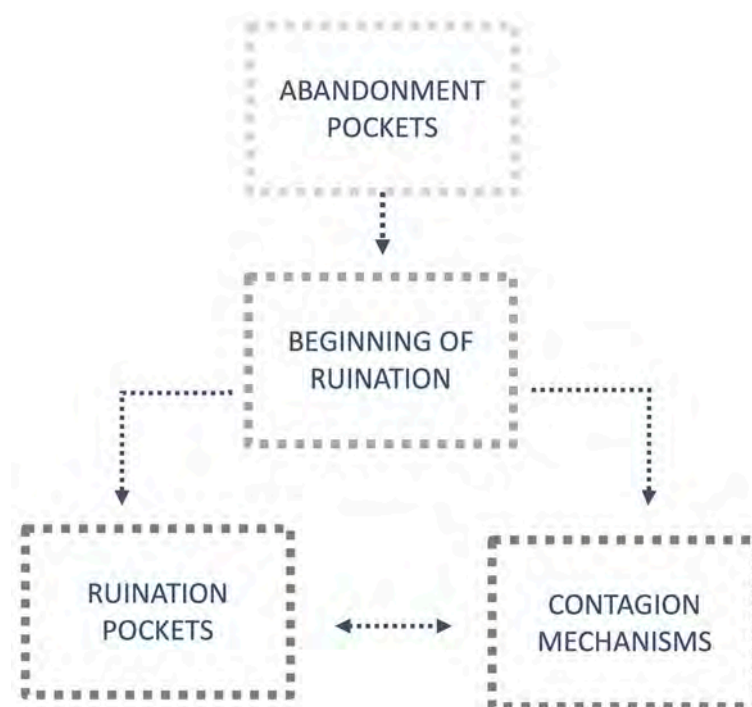
**Figure 14.** Diagram of the ruination process detected in the Granfonte neighbourhood.

The process observed in the neighbourhood can thus be represented by the diagram in Figure 14. Prolonged abandonment by pockets induces the initiation of ruination. The contagion effect triggers further mechanisms that generate ruination pockets, which continues to feed contagion mechanisms on the neighbouring units.
