## A Methodology for Approaching the Reconstruction of Historical Centres Heavily Damaged by 2009 L'Aquila Earthquake

**Abstract** The paper illustrates the preliminary results of a research carried out on a historical centre heavily damaged by 2009 L'Aquila earthquake; in particular it presents shortly the Rubble Removal Plan realized and more in detail, the analysis conducted on a sample block. The detailed knowledge of the block is essential for identifying probable causes that led to the present damage scenario and for planning consciously the reconstruction and restoration of the historical centre.

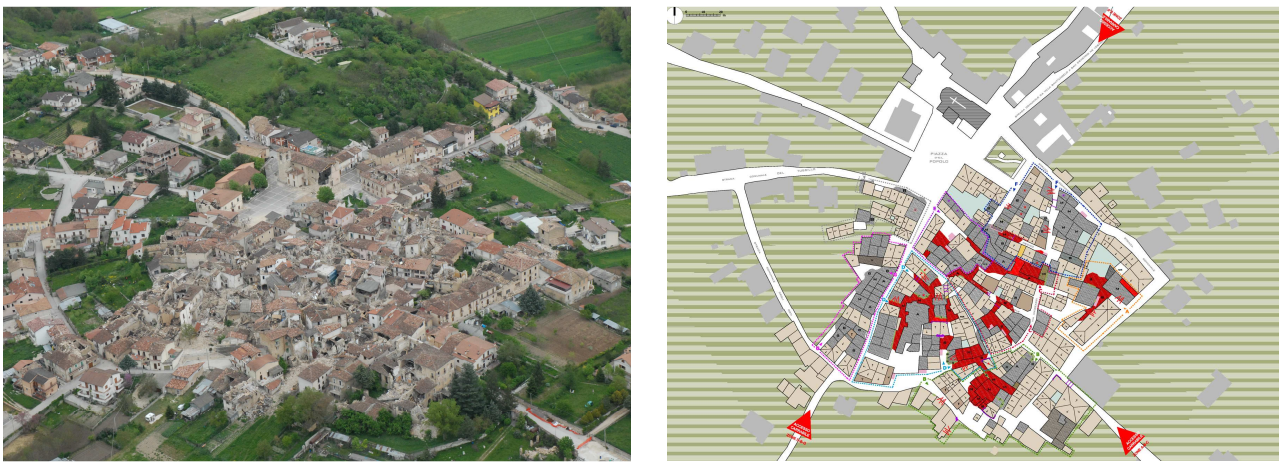
Figure 1: Aerial view of Villa Sant'Angelo historical centre (left) and “map of the collapse state” with the interruption of public streets due to the presence of rubble (right).

The need for a preliminary study entirely devoted to the design of a general “Rubble Removal Plan & Public Streets Securing” was motivated by the inaccessibility of the sites caused by both the presence of debris, that obstructs the open spaces (streets, squares, blocks’ internal courts) and the precariousness of many of the surviving building portions facing the public streets (Fig. 1-left).

The plan was drawn up following a methodology that can be concisely described by following 3 steps: (1) analysis of the collapses extended to the whole historic centre (map of the collapse state) (Fig. 1-right), (2) identification of the areas for which the rubble removal and the contextual securing of the facing fronts can be done without interfering with contiguous areas (intervention areas), (3) detection, for each intervention area, of pathways along which it is possible defining the logical sequence and timing of all required planning operations (Fig. 2).

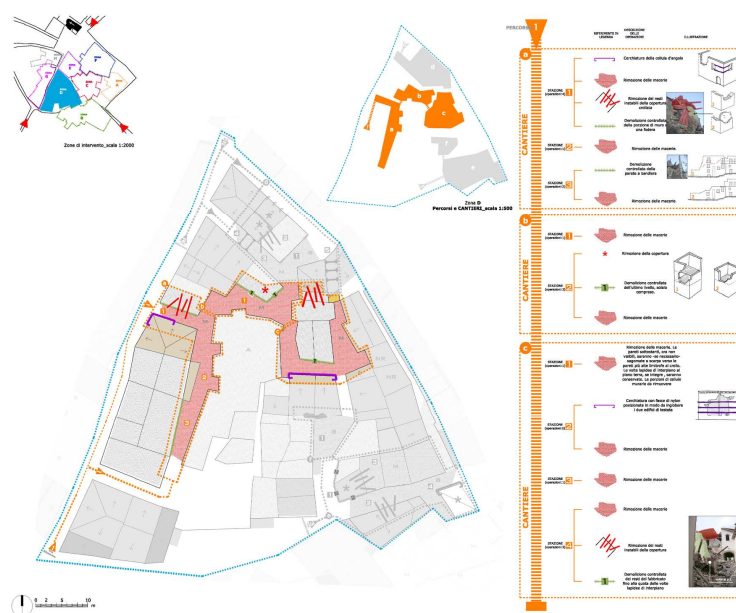
Figure 2: Detail of the “Rubble Removal Plan & Public Paths Securing”

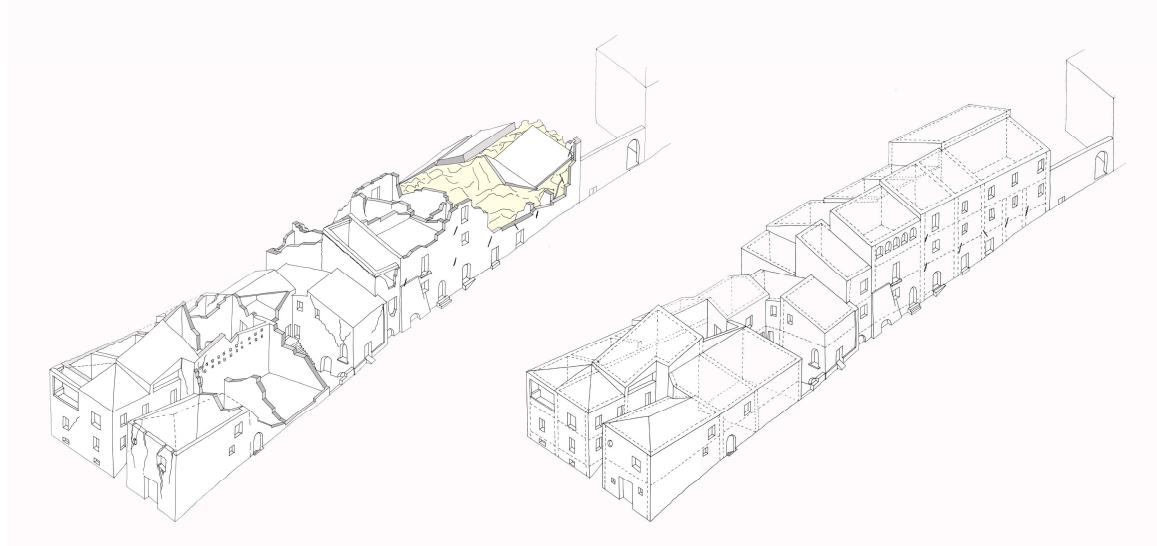
Figure 3: The sample block in the post and pre earthquake configurations.

Through these operations a detailed knowledge of the block consistency has been acquired yielding two key results. Firstly, the hypothetical but documented reconstruction of the block arrangement before the earthquake and its comparison with that produced by the earthquake (Fig. 3). Secondly, the identification of the vulnerability factors that may have promoted (or amplified) some of the damages and collapses occurred – eg., the replacement of the original timber roof structures

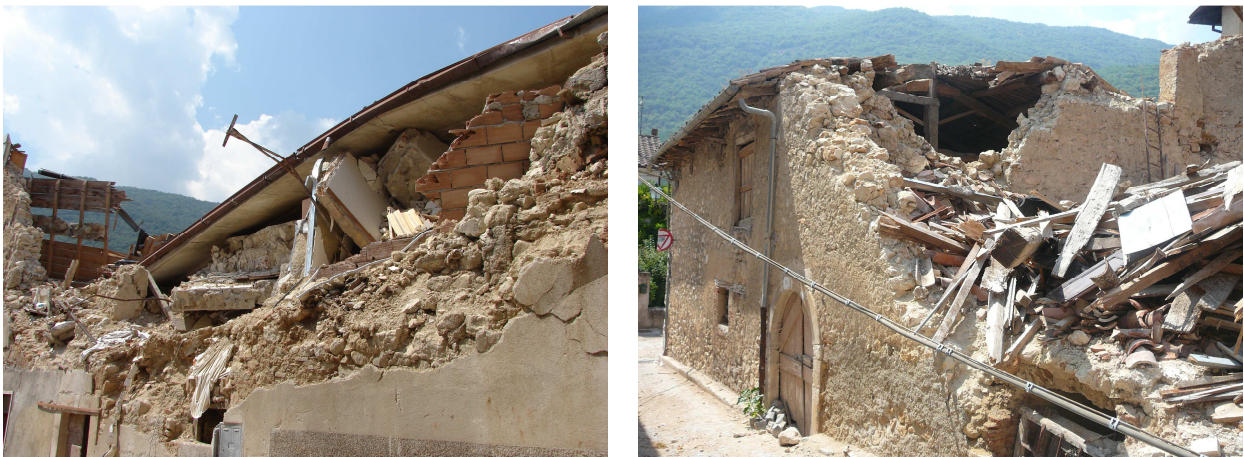
Figure 4: Vulnerability (heavy r.c. roof structure) and resistance (anchored trusses) factors

with heavier r.c or steel structures – as well as, on the contrary, the resistance factors that may have reduced the effects of the earthquake – eg., the presence of anti-seismic historical protections (Fig. 4).

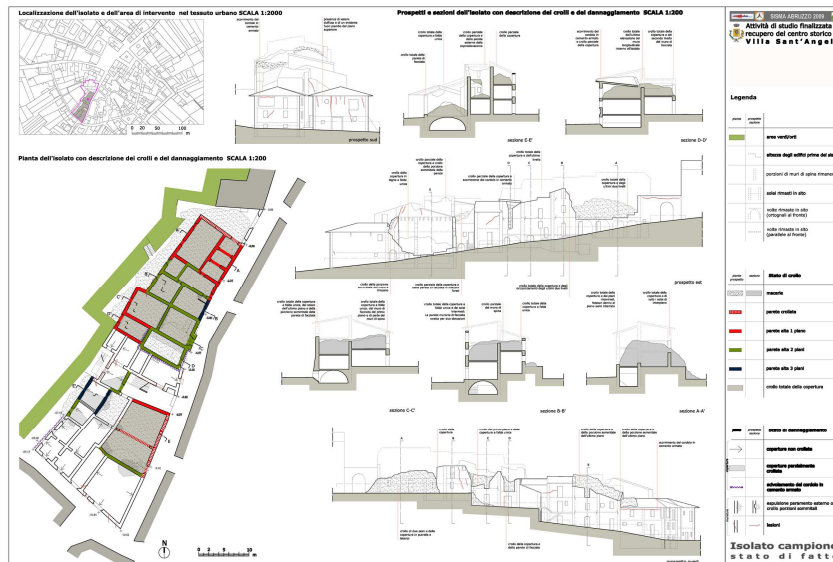
Figure 5: Present state of the sample block, with the extent of collapses, the location of rubble inside the houses and the cracks in surviving buildings.

The comparison between the actual and the project states (Fig. 5, Fig. 6) allows controlling the amount of demolition to be carried out; such an aspect is of significant importance for the overall situation of the historical centre of Villa Sant'Angelo, where – given the widespread state of collapse (more than 50% of the urban texture) – could easily be implemented more extensive demolition than those effectively necessary.

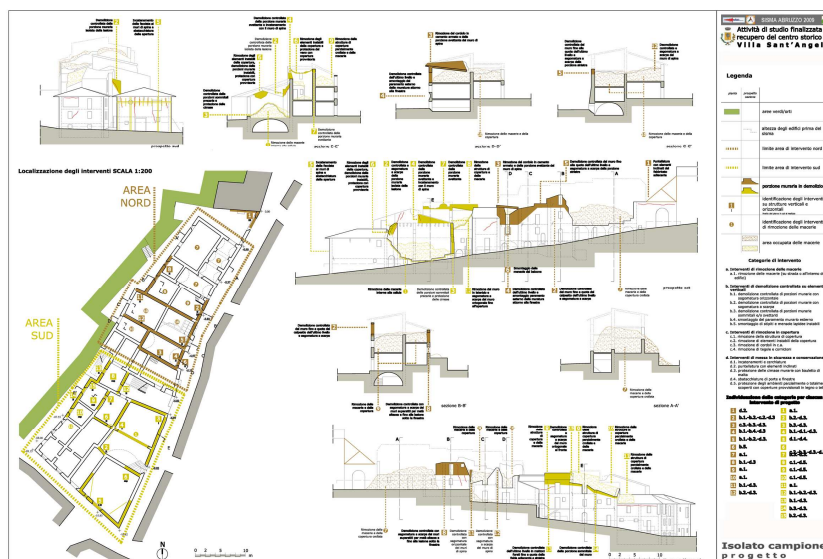
Figure 6: Project state of the sample block
