Sustainable Fruition of Cultural Heritage in Areas Affected by Rockfalls

Simone Mineo

and Giovanna Pappalardo *

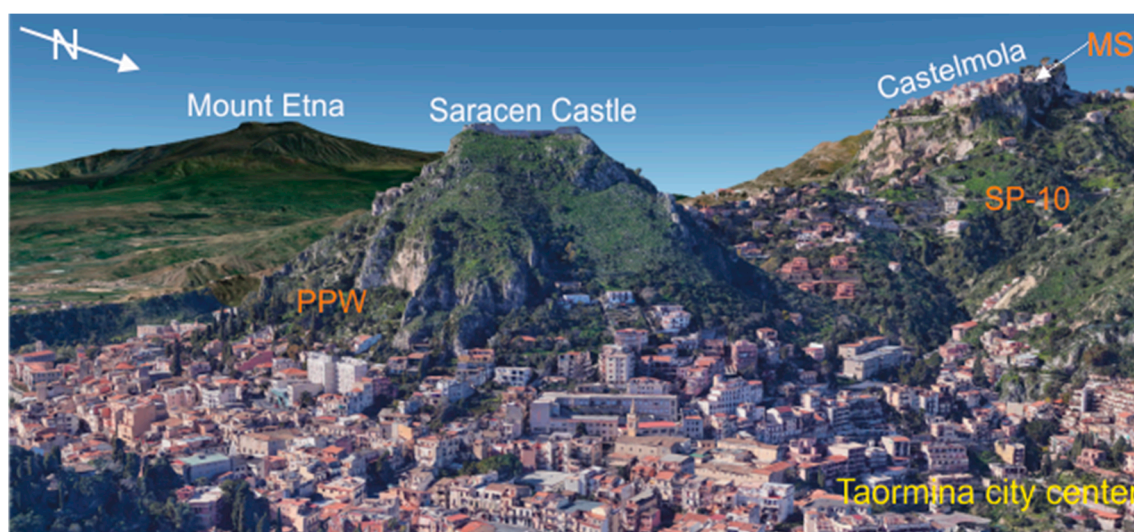
Figure 2. Location of the most relevant spots threatened by rockfall in the Taormina complex. Key: PPW—pedestrian pathway; SP-10—Provincial Road 10; MS—Castelmola Main Square.

Although on the one hand, the territory hosting such cultural heritage allowed its historical development thanks to the strategic setting, i.e., steep cliffs dominating the Ionian coastline, on the other hand, it is the main cause of risk arising from natural events. In fact, this territory has been suffering a relevant rockfall problem for decades. The geological and tectonic setting are mainly responsible to a poor-fair geomechanical quality of the rock masses (e.g., [32–35]), which often gives rise to rock volume detachments, especially after heavy rainfalls. The most critical detachment points are located along carbonate rock masses belonging to the Liassic greyish-white limestones and dolostones formation described by [36]. This represents the sedimentary cover of a metamorphic terrain, which is the basement of the Peloritani Mountains, a regional nappe-pile edifice composed by distinct tectonic slices. Most of the rockfalls have never been documented, although [37] provided a list of the most remarkable ones, which is herein integrated with the most recent ones (Table 3). This analysis highlights that in the latest years there is at least one event per year causing safety problems, thus deserving a critical attention. The main elements at risk of the area are represented by infrastructures connecting Taormina to Castelmola (both pedestrian and vehicular paths) (SP-10), the main square of Castelmola (MS-viewpoint on Taormina) and the pedestrian pathway (PPW) to reach the Taormina castle from the city center. This condition represents a threat to the site fruition, especially in periods with a high tourist rate (Figure 2).
