## Seismic Analysis of Traditional Stone Rural Buildings: Case study of a one-storey building

C. Arcidiacono (\*), S. M. C. Porto (\*), G. Cascone (\*)

**Cómo citar este artículo/Citation:** Arcidiacono, C., Porto, S. M. C., Cascone, G. (2015). Seismic Analysis of Traditional Stone Rural Buildings: Case study of a one-storey building. *Informes de la Construcción*, 67(537): e053, doi: <http://dx.doi.org/10.3989/ic.13.039>.

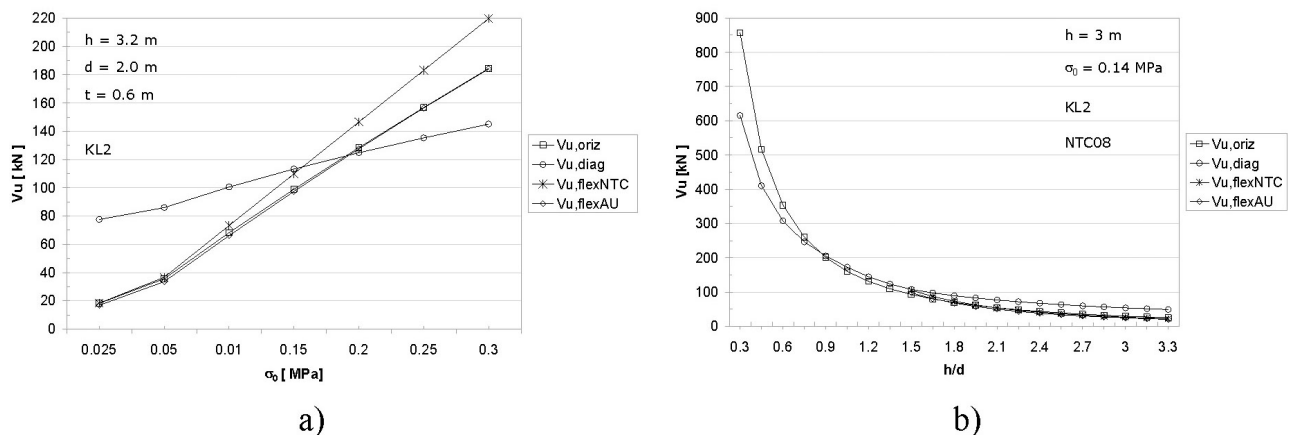
Figure 7. Pier-panel strength capacities  $V_u$  in relation to: a) the normal stress  $\sigma_o$  exemplified for a pier panel with slenderness equal to 1.6 in the KL2 case; b) pier-panel slenderness, for pier-panels having a 3 m height and subject to a normal stress  $\sigma_o$  equal to 0.14 MPa in the KL2 case.

- walls subject to low values of  $\sigma_o$ , as occurred in the analysed one-storey TRB, showed bed-joint-sliding shear failure until a threshold value where it turned to diagonal cracking shear failure, as exemplified in Figure 7a for pier-panels having a slenderness value of 1.6, and wall thickness equal to 0.6 m, in the KL2 case;
- squat masonry pier panels experienced diagonal cracking shear failure for low values of slenderness, bed-joint-sliding shear failure for higher values of slenderness, whereas flexural failure was attained for the highest values. This variation of pier-panel failure mechanisms in relation to their slenderness is shown in Figure 7b which exemplifies pier-panel strength capacity  $V_u$  in relation to slenderness for pier panels of 3 m height and subject to normal stress  $\sigma_o$  of 0.14 MPa, in the KL2 case.

ings and NTC08 overestimates the ultimate force ( $V_{u,flexNTC}$ ) (Figure 7a), resulting in wrong predictions of failure mechanisms for some values of the applied axial force (41). Also this overestimation could affect pier-panel characteristic curves as well as the capacity curve of the whole structure.
